## J-44175 Fuel Composition Tester

J-44175 Fuel Composition Tester	1
Tire Pressure Monitor Tips	1
Coolant Fan Motor Replacement	2
Lifting and Jacking	2
Coolant Leak at Upper Radiator Hose	2
100% Caster/Camber Validation	2
Underhood Electrical Center Cover	4
Rear HVAC System Conditions	4
Programming Immobilizer Keys	4
Steering Wheel Position	4
Liftgate Creak Noise	5
Front Axle Switch Circuit	5
PTO Drive Applications	5
Center Cap Installation	5
Cup Holder Liner	6
Locating Unit Repair Information in SI	6
Torsion Bar Front Suspension	6
Musty Odor from HVAC	6
Pickup Box Dimensions	7
Remote Start Features Clarified	7
Voltmeter Fluctuation	7
Fix It Right the First Time	8
Know How Broadcasts for March	8

GM TechLink is a monthly magazine for all GM retail technicians and service consultants providing timely information to help increase knowledge about GM products and improve the performance of the service department.

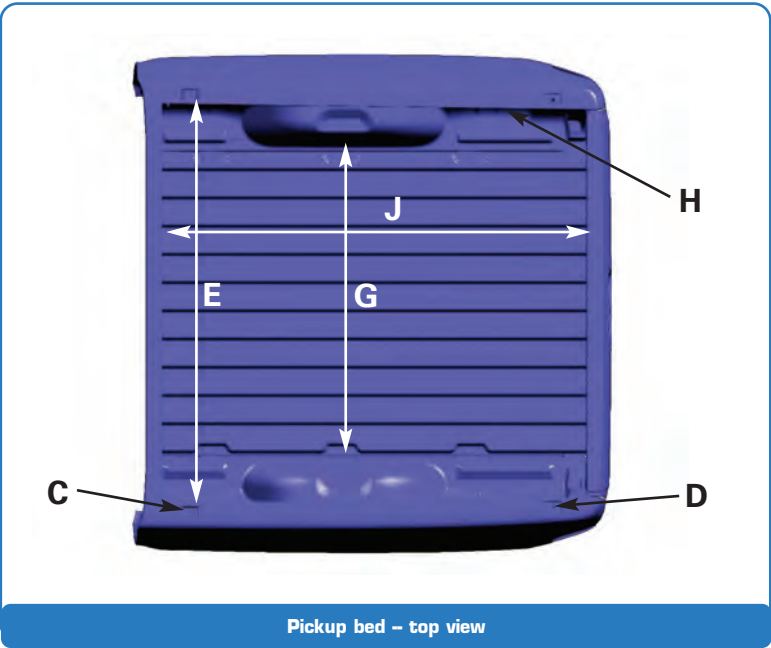
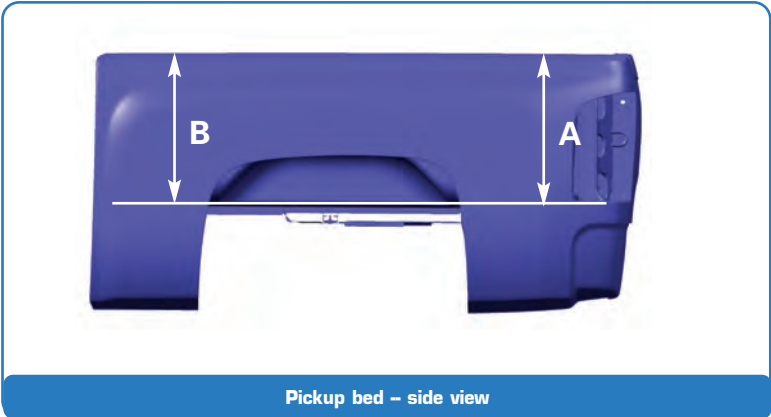
- A. The new box has a 40mm increase in height from the load floor to the top of the side bed rail in the rear.
- B. The new box has a 30mm increase in height from the load floor to the top of the side bed rail in the front.
- C. The front stake pocket location is 52mm rearward compared to the Classic truck box.
- D. The middle (if equipped) and rear stake pocket locations are unchanged.
- E. The distance across the truck (side to side) between the stake pockets is unchanged.
- F. The stake pocket size is unchanged.
- G. The distance between the wheel wells is 25.3mm wider on the new box.
- H. The side bed rail attachment flange is unchanged.
- J. The top view opening of the box is unchanged with one exception. The fore/aft length is shorter by 33mm due to a change in the front panel flange.
