## Integrated Center Stack (ICS)

GM TechLink is a monthly magazine for all GM retail technicians and service consultants providing timely information to help increase knowledge about GM products and improve the performance of the service department.

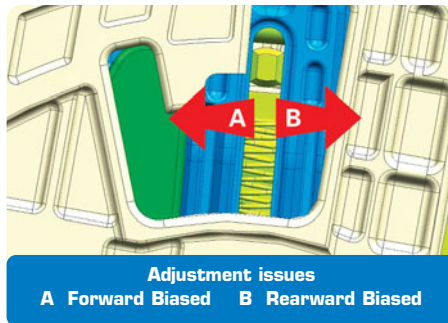
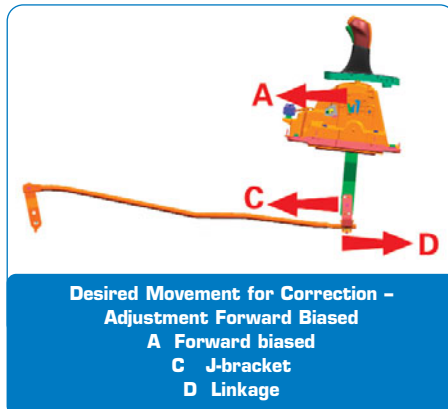
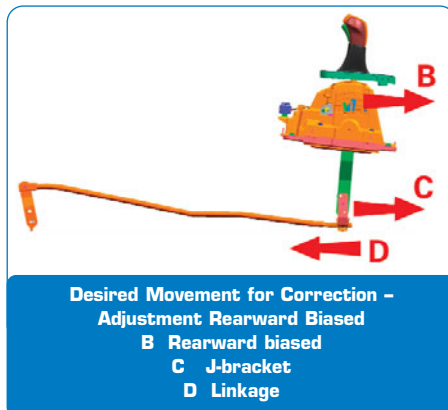
The linkage adjustment procedure is critical for proper transmission operation; therefore, several checks need to be performed after the linkage is adjusted:

- Inspect the operation of the starting system with the shift lever in each position. The engine should crank only when the lever is in the Park or Neutral position.
- Ensure that the feel of the shift detents align with the gear indicator.
- When in each gear, apply the button and release. Then slightly reposition the handle fore-and-aft in the vehicle. The button pawl will make a clicking noise if it is caught on a

control mechanism gate. The button should not get caught up on the control mechanism gate in any gear. Readjust and retest if necessary.

- Return the lever to the Park position and check for proper engagement. Park position should feel solid and not spongy. The shift lever should not be bottomed out on the stop bumper when engaging the Park position. Readjust and retest if necessary.
- With the ignition on and the engine not running, ensure a smooth transition from position D to Tap Mode and back. Ensure that the DIC changes to the gear indicator mode. If the DIC does not change to gear indicator mode, or any binding or rough spots are felt, repeat the linkage adjustment procedure and retest the system.

If any of the following conditions exist after performing the linkage adjustment, the shifter may need to be replaced. Refer to bulletin 41276.

DO NOT replace a shifter assembly without first attempting to correct the condition with the linkage adjustment procedure. Refer to SI for the proper service procedures.

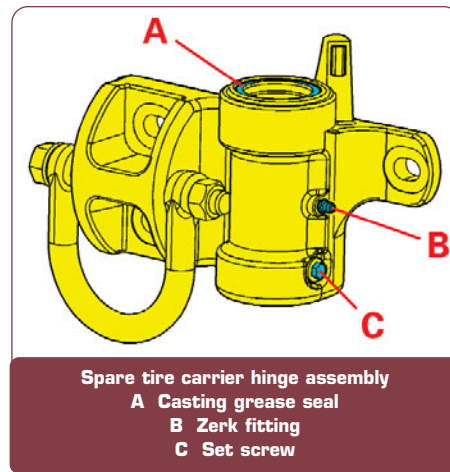
**IMPORTANT:** Under normal conditions, the hinge assembly will NOT require lubrication.

Remove the M6 set screw and the 1/4 inch plug (if equipped) above the set screw. Install a grease (zerk) fitting where the 1/4 inch plug was located. Some vehicles have the zerk fitting installed during assembly. Apply grease and rotate the swing arm to ensure a uniform coating over the internal bushing.

When the grease begins exiting the set screw hole, stop applying grease

and reinstall the set screw. Tighten the set screw to 9 N·m (80 lb in).

Begin applying grease again, using the zerk fitting, and continue articulating the swing arm until grease is just visible on the casting grease seal.
