Wireless Headphones and Remote Controls

Techline News

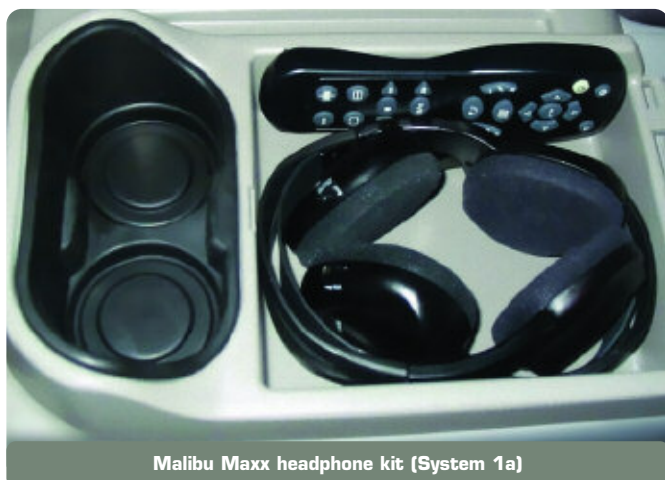
Malibu Maxx headphone kit (System 1a)

The following headphone kit (p/n 15140532) is released for the 2005-07 Malibu Maxx only. The remote control will not work with any other GM vehicles.

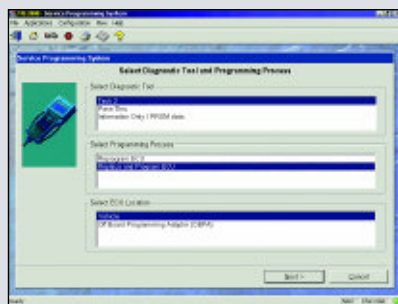
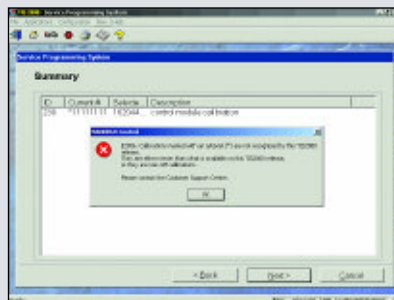
TIP: The default choice is **Reprogram**, and if you use it, you will receive an ERROR message. If after following this procedure, you still get the ERROR message, contact Techline Customer Support Center.

The Reprogram choice is used only to reprogram a module that will continue to be used in the vehicle (installing the latest calibrations, for instance).

You now MUST select **Replace and Reprogram**. Then follow the remain-

der of the standard procedure to install the data into the replacement module.

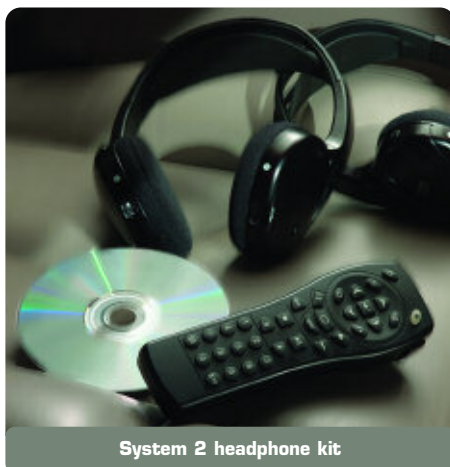
System 2 headphone kit

The following headphone kit (p/n 15072230) is released for the 2005-06:

TIP: The remote control will work only in these GM Vehicles.

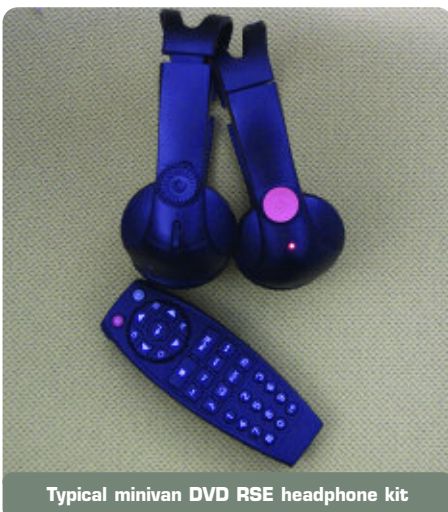
Typical minivan DVD RSE headphone kit

The following two kits (p/n 15136091 and 15136092) are released for the 2005-07:

TIP: The remote control will work only in these GM vehicles. Channel 2 of the wireless headphones will work only in these vehicles (Channel allows you to listen to DVD and Channel 2 allows you to listen to RSA).

TIP: If a kit is misplaced or was not shipped with the vehicle, follow established procedures for misplaced/missing components. The service part numbers for the kits are the same as the OEM part numbers.

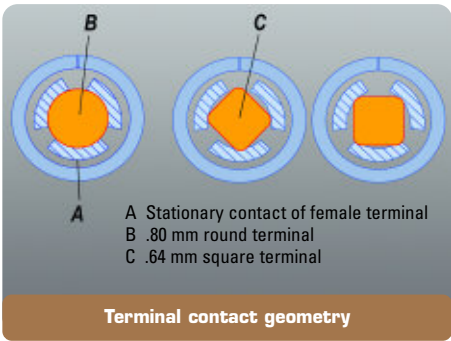
There are two different types or styles of male terminals that will mate with the .64 female terminal. These are the .80 mm round style (Delphi and Bosch), and the .64 mm square style (AMP/Tyco, Bosch, JST, Molex and Yazaki). The GM corporate intent is to use only the Yazaki .64 terminal in the future. So you will see more of this terminal in the future. A new crimp tool is being developed that will crimp the Yazaki square and Bosch round .64 terminals.

If a male 100 terminal (or test probe, or anything incorrect) is inserted into a .64 female, the .64 terminal may split. This destroys the terminal's retention capability. When that damaged .64 terminal is reconnected, tension is too low to ensure proper contact and continuity.

TIP: It is not recommended to attempt to distinguish between the .64 terminal and the 100 terminal just by looking. The best way to be sure is to use the .64 test probe (J-35616-64A) initially. If the J-35616-64A probe seems obviously too small, move to the 100 sized probe.

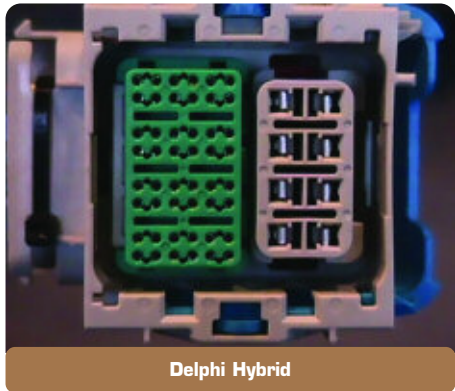
Delphi – Many different Delphi connector shapes and styles are in use. All Delphi .64 connection systems use terminal 15359541, which is found in the Delphi tray 4.

These connectors require the careful removal of the comb style TPA (Terminal Position Assurance). They will break very easily if extreme care is not used. Use the 15381651-2 terminal release tool pushed into the small hole between two terminal cavities.

TIP: Do not disassemble the Delphi connector body any more than removing the TPA and in some cases, a nosepiece that covers the small terminal release holes. It is very difficult to get all the ter-

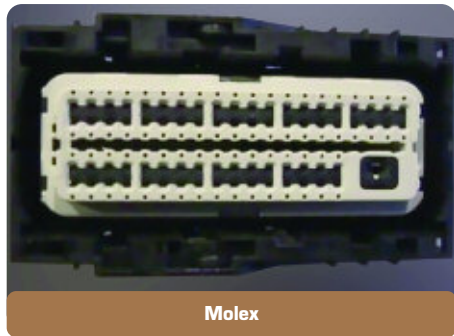
Molex – A new Molex connection system is used on some ECMs. It uses a square type .64 terminal number 33467-0003 or 33467-0005 depending on wire size. Both are found in Delphi tray 23.

There is only one style of this connector in use so far. The TPA surrounds the terminal area, and the color matches the ECM header color. Lift the TPA up slightly to the preset position. Use the gray J-38125-213 terminal release tool. Insert it into the small hole in the TPA next to the terminal you wish to remove. Once the new terminal has been pushed back into position, press the TPA back into place.

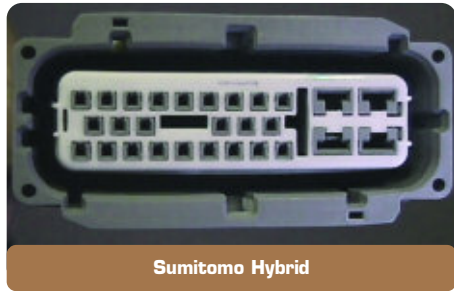
Sumitomo – A new Sumitomo connection system is used on some ABS modules. It uses a square type .64 terminal 8100-3455 in the Sumitomo tray 22.

There is only one style in use so far, but others will follow. At first glance, this connection system looks like it uses a terminal larger than a .64. The white TPA surrounds the terminal area. Lift it to remove. This is difficult and feels like it is going to break. Use the green 12094429 terminal release tool. Insert it next to the terminal you wish to remove and lift the plastic tang that holds the terminal. Once the new terminal has been pushed back into position, press the white TPA back into place.

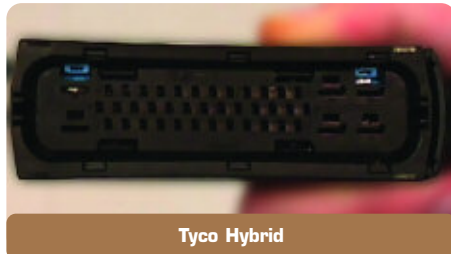
Duty Truck ABS module. It uses a square type .64 terminal 962885-5 in the Yazaki tray 15.

There is only one style of this connector in use so far. Use a small screwdriver to move the two tabs of the blue TPA out slightly to the preset position. Use the green 12094429 terminal release tool. Insert it into the small rectangular hole next to the terminal you wish to remove, moving the plastic tang that holds the terminal. Once the new terminal has been pushed back into position, move the blue TPA back into place.

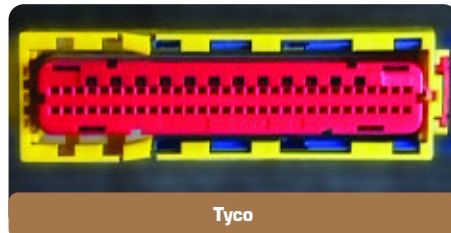
Another Tyco connection system is used on SD modules. It uses a square type .64 terminal. The service terminals in this connector are the terminated leads 1393365-2-SIR in the new SIR tray. There is only one style in use so far. Lift and remove the red TPA that surrounds the terminal area. Use the black 15315247 terminal release tool. Insert it next to the terminal you wish to remove and lift the plastic tang that holds the terminal.

Once the new terminal has been pushed back into position, press the red TPA back into place.

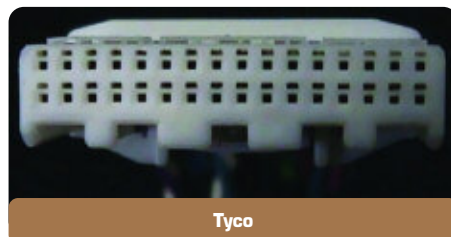
A Tyco connection system is used on sunroof modules and other small modules. It uses a square type .64 terminal 1123343-2 in the Lear tray 7.

There are several styles of this connector in use with different terminals. You must carefully lift the white TPA on the top of the connector. Do not remove. This TPA actually surrounds the terminal, so you will damage it if you try to get it completely out. Use the green J-38125-24 terminal release tool. Insert it next to the terminal you wish to remove and lift the

plastic tang that holds the terminal. Once the new terminal has been pushed back into position, press the white TPA back into place.

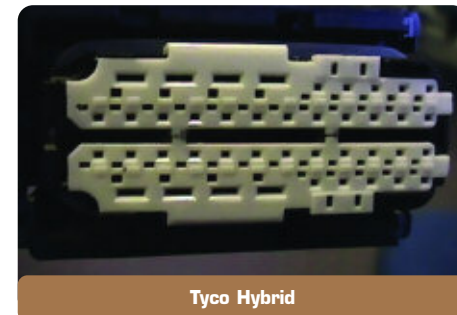
A Tyco connection system is used on the Transmission Control Modules (TCM) of the Cadillac SRX, STS and CTS.

This connection system also uses a square type .64 terminal 2-1411578-2 in the Yazaki tray 15. Remove the strain relief (the cover on top of the connector). Then, depress the lock tab on the side of the connector and move one of two white TPAs aside to the pre-staged position. Insert the green 12094429 terminal release tool into the small rectangular hole next to the terminal you wish to remove. Move the plastic tang that holds the terminal. Once the new terminal has been pushed back into position, move the white TPA back into place. This connector is shown in the Wiring Systems section of SI.

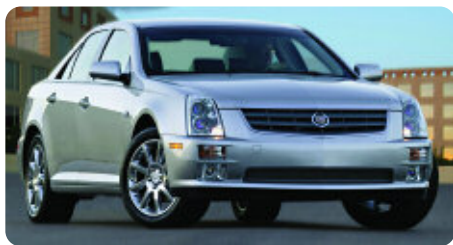
The STS uses the same basic keyless system as the XLR (TechLink, Feb. 2004) and Corvette (TechLink, Aug. 2004). The STS operates at the same frequencies as the XLR and Corvette (315 MHz for domestic, 433 MHz for Europe).

The STS may be susceptible to RF (radio frequency) interference or EMI (electromagnetic interference).

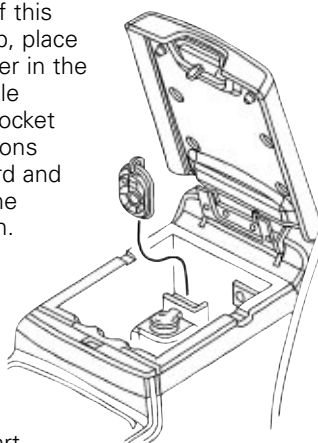
TIP: If the keyless access transmitter is not detected inside the vehicle while trying to turn the ignition off, the NO FOB OFF OR RUN message displays.

The vehicle may be near a strong radio antenna signal, causing the keyless access system to be jammed. The vehicle will remain in ACCESSORY until OFF or START has been pressed or 10 minutes has expired.

TIP: The owner is advised to move the transmitter to different locations within the vehicle. If this does not help, place the transmitter in the center console transmitter pocket with the buttons facing forward and then press the START button. If the vehicle battery is sufficiently charged, this action will ALWAYS enable the vehicle to start.
