## Safe Multimeter Practices

### Contents

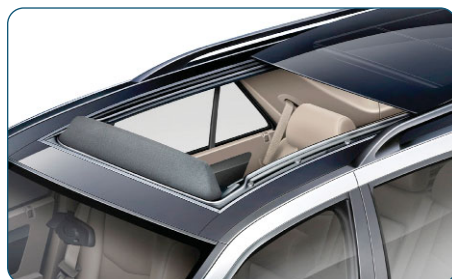
The sunroof may stop and auto-reverse direction when the express open or closed feature is selected. The sunroof motor reverses when it experiences high current draw caused by excess friction in the guide tracks. Due to the size and design of the glass, the rear guide tracks may become dirty from exposure to environmental elements. Lack of proper maintenance, cleaning and lubrication may also be a cause.

- Clean the guide rails with brake cleaner, then lubricate with Rheosil 500F (obtained from TAI Lubricants at 1.302.326.0200). Rheosil 500F is the only lubricant GM recommends for the rear tracks.
- When the sunroof glass is removed, operate the sunroof drive system to confirm that there are no concerns with the front drive tracks or drive cables.
- Install softer durometer rubber guide caps p/n 25880591 to the white plastic guide shoes.
- If other remedies are not successful, replace the motor with a high-current version, p/n 15932104. It is not necessary to replace the drive motor in every case

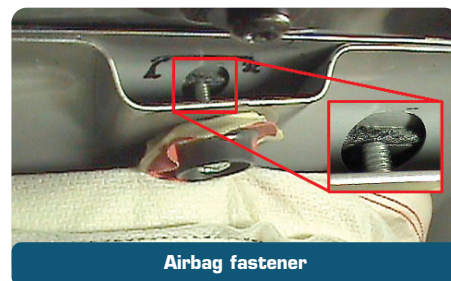
Rear alignment pin

- Sunroof module or glass panel fasteners may be loose. The specified clamp load is low and must be maintained. Also be careful not to overtorque. See the over-torque tip earlier.
- Sunroof frame alignment pins may contact the roof sheet metal. Refer to bulletin 06-08-67-012B for details.
- Rear roof rail airbag fastener may contact the side door ring sheet metal. Refer to PIC4359A for details of the condition and repairs.
- The sunroof module fasteners may contact the sunroof SMC frame, creating a noise. See PIC4359A for details.
- The copper drive cable tube may contact the SMC frame or a tie strap may contact the SMC. Isolate both contact areas with flocking tape.
- Conditions of wind noise at the leading edge of the glass may be corrected by following the procedures in bulletin 07-08-58-002.
