Cylinder Bore Liner Replacement

A new tool EN-45680-850 has recently been released to replace cylinder bore liners in the 2.2L Ecotec four-cylinder engine (RPO L61 VIN F or D).

GM TechLink is a monthly magazine for all GM retail technicians and service consultants providing timely information to help increase knowledge about GM products and improve the performance of the service department.

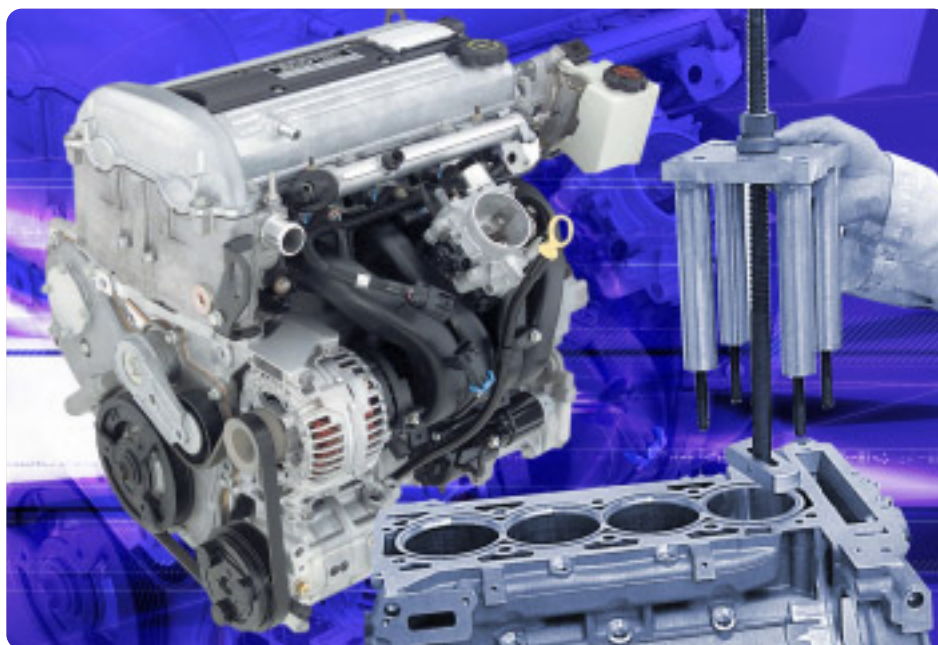
The cylinder block of the Ecotec engine is lost-foam cast aluminum alloy,

with pressed-in centrifugally-cast grey-iron cylinder bore liners.

In production, the liners are pressed into the block, then the deck of the block and liners are machined all at the same time. The production specification calls for the liners to be flush with the block, to + 0.02 mm (0.0008 in.) above deck.

The cylinder liner is beveled at the bottom end to help guide the liner into the block bore. And the top of the liner is slightly flanged, fitting into a counterbore in the block. This ensures that the liner is properly seated when it is pressed into place.

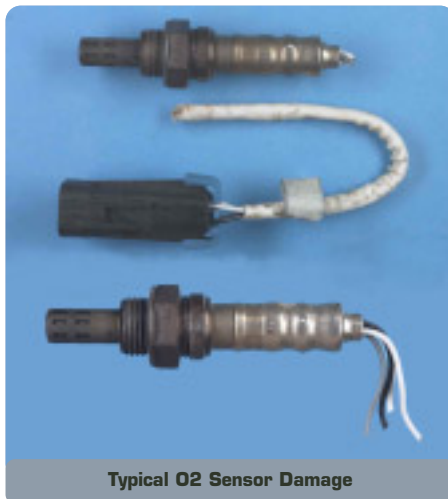
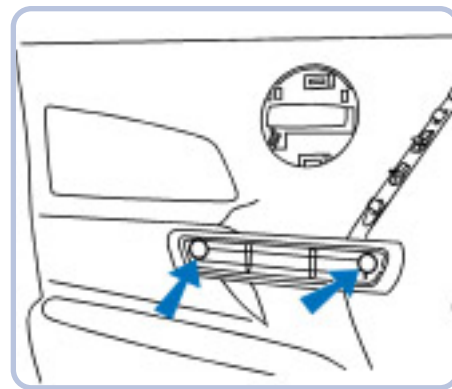
Door Trim Panel Removal

When removing the door trim panel on the 2004 Grand Prix, do not use a standard socket to remove the hexhead screws located in the pull handle of the front or rear door trim panels. Some of the tubes are too narrow and the standard socket, when pushed down onto the screw will split the plastic tubes.
