Stretchy Belt Debuts in H3 V8

GM TechLink is a monthly magazine for all GM retail technicians and service consultants providing timely information to help increase knowledge about GM products and improve the performance of the service department.

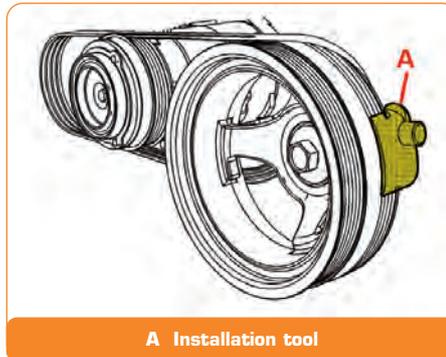
A Installation tool

1. Position the belt behind the rear face of the balancer and off of the AC pulley. Install the tool onto the balancer.

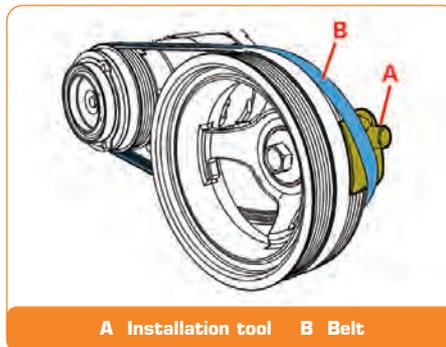
A Installation tool B Belt

2. Slide the tool upward, installing the belt onto the tool. Slide the tool downward, positioning the belt onto the AC pulley and applying light tension to the belt.

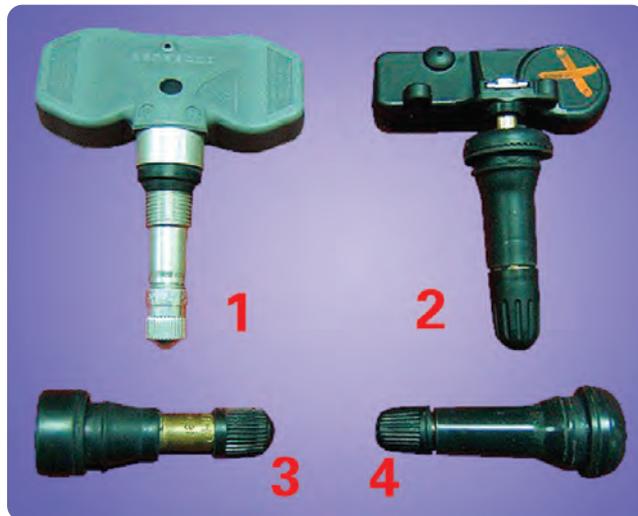
1. **Clamp-in type TPM sensor** – characterized by a metal non-replaceable valve stem secured by an attaching nut visible on the outside of the wheel.
2. **Snap-in TPM sensor** – characterized by:
 - a. Black rubber valve stem
 - b. Valve stem cap longer than traditional non-TPM stem
 - c. Valve feels thicker than non-TPM valve
3. **Non TPM** – heavy duty brass bodied valve stem.
4. **Non TPM** – common standard duty valve stem.
