Electronically Controlled Air Suspension (ECAS) Procedures

Techline News

GM TechLink is a monthly magazine for all GM retail technicians and service consultants providing timely information to help increase knowledge about GM products and improve the performance of the service department.

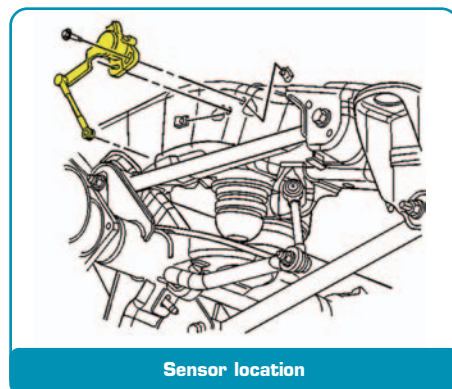
This procedure has been revised to include use of the fabricated D-height gauge block described above to establish rear axle position relative to the frame, when adjusting the sensor.

TIP: It is no longer necessary to remove the air lines (depressurize the system) when calibrating the sensor.
