## Techline News

# New Radio Antenna Connector

# STS Tire Pressure Monitoring System Issues

# Tire Pressure Monitoring Issues

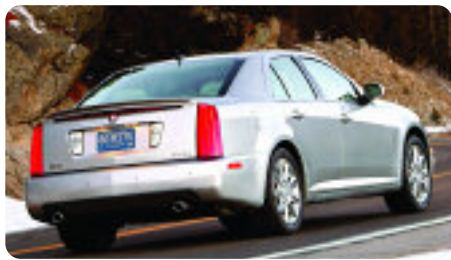
A TPM system malfunction can occur if the connection at the RCDLR is loose, the center wire in the coax is bent, or the shielding is not fully secured to the connector end, causing a poor connection.

and are received by the RCDLR through the antenna grid in the vehicle's rear window. Extremely small cracks may develop in the rear defroster grid that are not visible. When the defroster is turned on, micro-arcing of electrical current that occurs at the cracks resonates at a frequency of 315 MHz. Due to the close proximity of the defroster grid to the antenna grid, this micro-arcing (noise) can interfere with tire pressure sensor transmissions, causing a TPM system malfunction to occur.

To verify this condition, use your scan tool to clear any stored TPM DTCs, test drive the vehicle above 20 mph (32 km/h) for at least 10 minutes, to verify normal system operation. Turn on the rear defroster and note if the TPM system malfunction correlates with rear defroster activity. If so, replace the rear window.

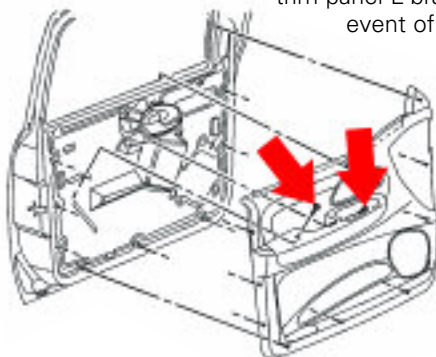
## Front Door Trim Panel Replacement

In SI Document 734557, the procedure has been modified for Front Side Door Trim Panel Replacement on the 2002-05 Envoy, Rainier, and Trailblazer. The illustration now has callouts showing the two bolts that must be removed before removing the panel from the vehicle. Failure to remove both bolts will result in damage to the trim panel L-bracket(s). In the event of damage, the

L-bracket(s) are not serviced separately, but are included with the arm-rest assembly available through GMSPD.
