A Monthly Publication for GM Dealership Service Professionals

Active Fuel Injector Tester

TECHtink .

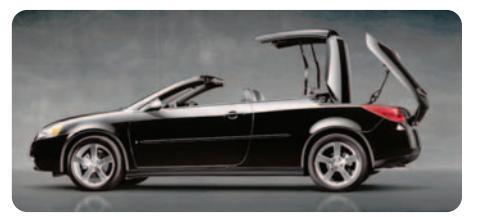
This will prevent a retractable hard top operational issue caused by a low battery state of charge.

The vehicle should be started and the engine running when demonstrating and cycling the top multiple times.

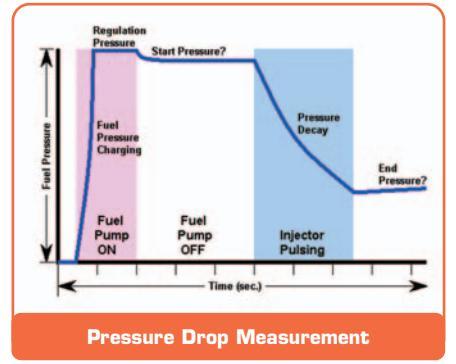
- Measurement is based on starting and ending fuel rail pressures
- Fuel pressure gauge must be recorded manually
- Dynamic fuel properties during the test may affect readings

- Consistent timing of each step in the procedure is difficult to maintain across all of the injectors. This can lead to differences in the
- conditions under which each injector was tested, resulting in an overall poor technical test.
- Fuel injector flow properties are determined indirectly through the fuel pressure drop of each injector.

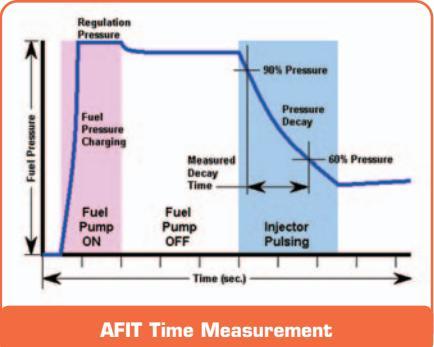
AFIT Time Measurement

- The amount of time it takes for the fuel pressure to sweep through the 90% - 60% of available fuel pressure is measured. This is the window in which fuel injectors operate most of the time.
- The injectors are all tested and compared at the same pressure points and the timing of each step in the process is consistent.
- All measurements are captured digitally, and the sequence is fully automated.
- Time measurement strategy is a better indication of the injector flow properties.
