## Vehicle Interior Cleaning

Bulletin 06-00-89-029A has been released to update information about vehicle interior cleaning.

## Xenon Lamp Control Module

## Oil Filter Debris

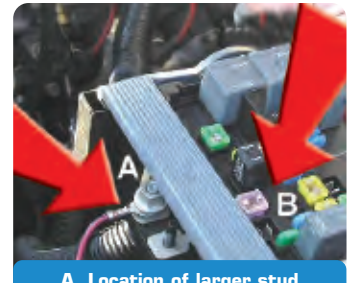
A Location of larger stud  
B Existing fuse

4. After completing the under-IP connections to the electric brake controller, open the hood and locate the red wire taped to the harness between the under-hood electrical center and the driver side front fender.
5. Break the tape on the red wire and pull the wire toward the front of the vehicle.
6. Remove the cover from the electrical center.
7. Place the terminal on the larger of the two studs at the front of the electrical center and secure with an M8 nut.

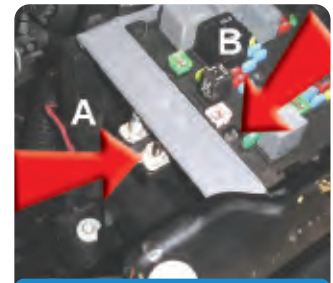
A Location of smaller stud  
B Install fuse
