Proper Wheel Balancing Techniques

Bulletin 07-03-10-017 was recently issued to address a wheel balance condition when using an off-car tire balancer.

Techline News

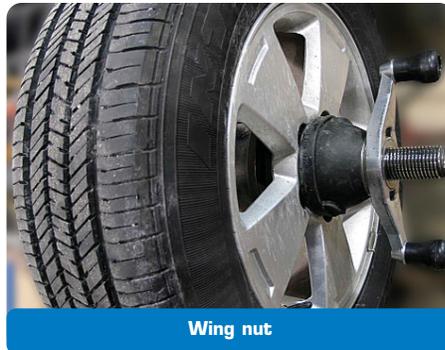
As described above, make sure the cone contacts the wheel's center hole

without bottoming out. Install the cone to the balancer shaft. Install the wheel to the shaft, install the wing nut and tighten.

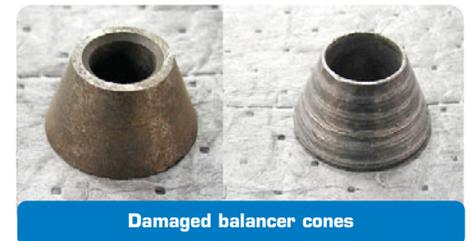
Balancer cones as well as backing/clamping plates and the screw and arbor on the machine need to be kept free of rust, corrosion, grit and dirt. They must not have physical damage from rough handling. Essentially, these parts should be maintained and cared for at the same level as the centering cones and bell clamps of a brake lathe. The parts can be cleaned of dirt and minor corrosion. Minor dents and damage can be remedied with a small whetstone. Major damage or corrosion requires replacement of the involved component.

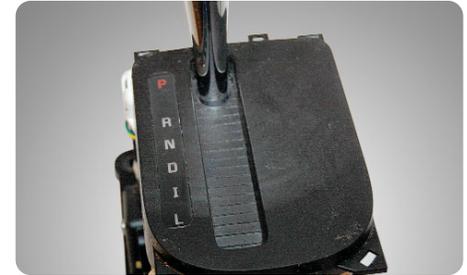
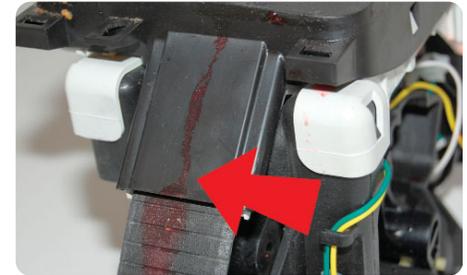
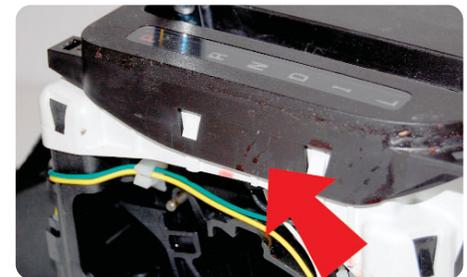
Pry bezel to remove

Inspect for spilled beverage

TIP: There is a small fiber washer on the shaft of the BTSI solenoid that is in a direct line below the edge of the housing. If liquid is spilled onto this washer, it may become saturated.

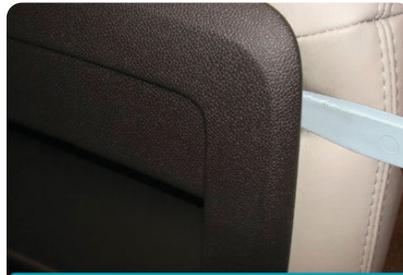
Inserting flat-blade tool from side

Insert a flat-blade tool from the side and push inward on one of the top retainer clips to release the panel, while pulling rearward at the top of the panel. Repeat on the opposite side.

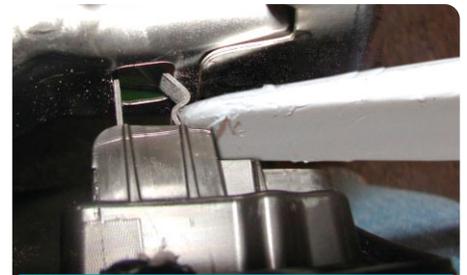
Depressing clip

TIP: The clip has a notch for placement of the flat-blade tool.
