Navigating the Upgrades in SI for 2005

Techline News

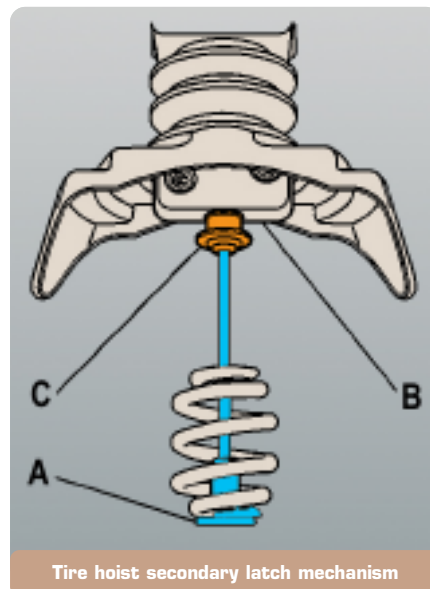
While holding the latch pin (B), fully depress the latch button (C) and release the secondary latch from the hoist assembly. Some side-to-side and/or up-and-down movement may be necessary to disengage the latch mechanism.

Continue turning the hoist shaft counterclockwise to lower the hoist the rest of the way.
