A Monthly Publication for GM Dealership Service Professionals

Techline News

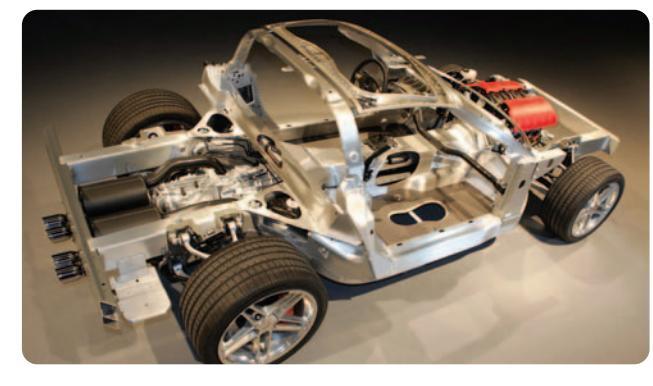
Aluminum Frame Thread Repair

becomes damaged, it's necessary to remove the damaged part and replace it with a solid, thin-walled, key-locking, stainless steel keysert. SI document 1796206 explains the procedure for using the CH 48106 Suspension Thread Repair Kit.

Use the CH-48106-1 extracting tool to remove the damaged insert.

A. With the insert removed, drill out the damaged threads using drill bit CH-48106-2.

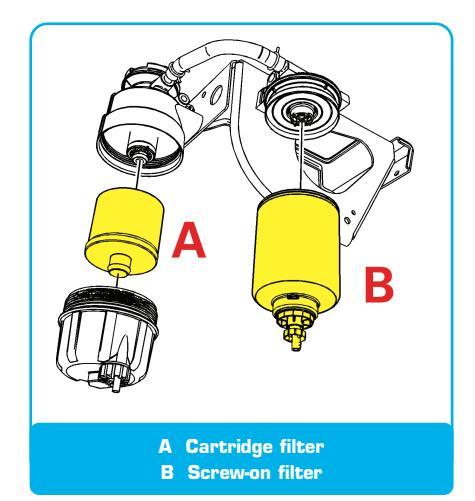
A new fuel filter kit has been developed for the 2006 Chevrolet Express and GMC Savana vans with 6.6L diesel engine.

When servicing the fuel filters on these vans, both fuel filters need to be replaced. The fuel filter kit p/n 19149845 includes a cartridge style filter located in the diesel fuel conditioning module (DFCM), a screw-on style fuel filter and the necessary seals.
