A Monthly Publication for GM Dealership Service Professionals

General Motors DEXRON®-VI

Global Service-Fill Specification

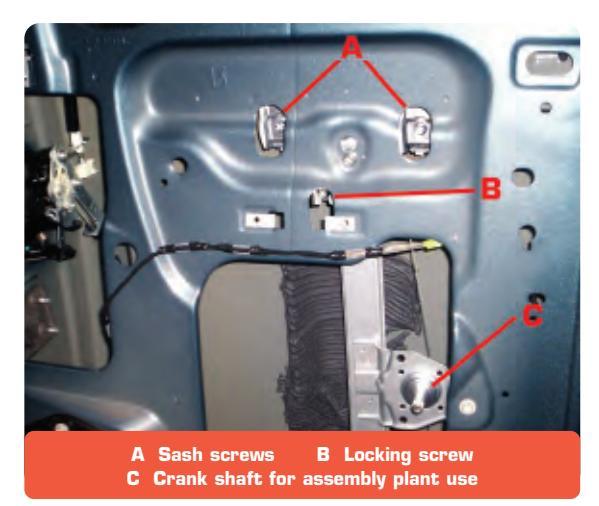
Fixed Glass in Rear Side Access Doors

This information applies to 2007 (not Classic) extended cab pickup trucks with fixed glass in the rear side access doors.

In the assembly plant, a manual window regulator and crank handle are temporarily used to raise the glass into position after the glass is installed into the run channel. Two sash screws and a locking screw secure the glass in the closed/up position. The locking screw attaches the regulator slide to the door sheet metal to prevent it from moving down after installation. A trim panel without crank hole completes the assembly.

TIP: Loosen the locking screw before lowering the glass for removal or repair.

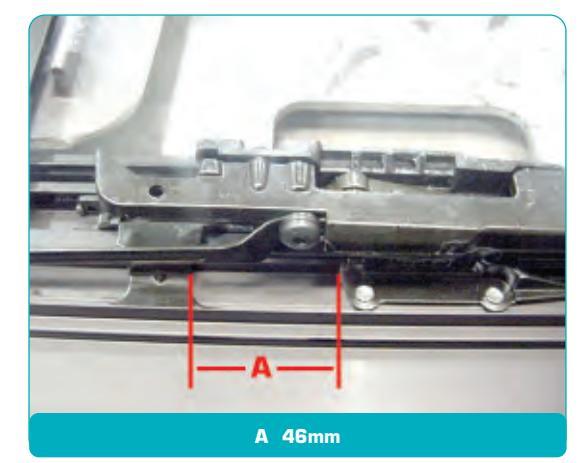
This information explains how to time the sunroof on the VUE, Equinox and Torrent.

- 1. Using the vehicle switches, move the sunroof glass panel as near to the closed position as possible.
- 2. Without removing any wiring connections, unbolt the motor from the sunroof beam. Once the motor is removed, the

sunroof mechanism will be free to move.

3. Remove the glass and manually push the right and left drive cable plate until the closed position is reached.
