EVAP System Operation

2000-02 Chevrolet Prizm
2003 Pontiac Vibe

Techline News

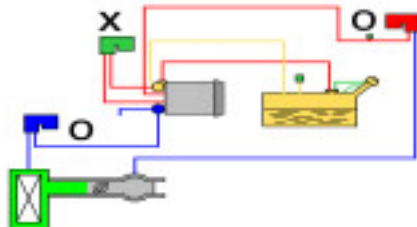
1. Normal Operation, During Purge

Both the purge valve and switching valve are closed and the vent valve is open. Under this condition, as vapors form in the fuel tank, they are routed to the canister. The calibration of the drain port passage check ball in the atmospheric valve is set at 5.5 in. H₂O, and above that pressure, air is allowed to pass through the drain hose to atmosphere. On most other systems, this air is allowed to pass through the vent solenoid to atmosphere.

Normal Operation After Ambient Air (Cold) Start -- When engine coolant temperature reaches 74° C (165° F), the purge valve opens, applying manifold vacuum to the vapor chamber of the canister. Because the vent valve is already open, manifold vacuum draws air through the canister. This draws vapor into the engine to be burned. The switching valve remains closed.

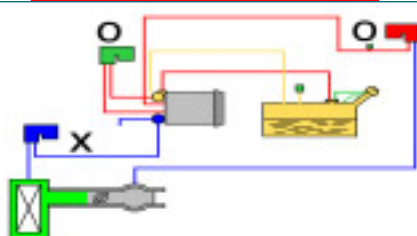
2. Large Leak Test, Vacuum Increase

switching valve opens. The purge valve remains open. This causes vacuum to increase in the entire system. Vacuum is detected by the pressure sensor in the fuel tank. If the vacuum does not increase, or increases beyond the specified limit, P0440, P0441, and P0446 codes will set.

TIP: Because more than one code will set, it's recommended that you begin diagnosis with the code set in Freeze Frame Failure Record.

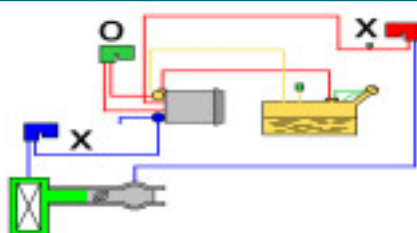
3. Large Leak Test, Vacuum Decay

The purge valve is now closed, trapping vacuum in the EVAP system. Now, the pressure sensor watches to see if, or how much, the vacuum decreases. A rapid decrease in vacuum indicates a large leak. This will cause a code P0440 to set. This could indicate a leaky filler cap, a loose fitting, or other large leak.

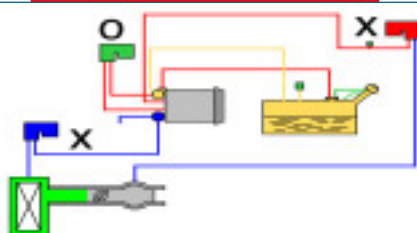
4. Small Leak Test -- If the system passes the large leak test, the pressure sensor continues to monitor the trapped vacuum. A slight vacuum decrease indicates a small leak. The EVAP system must be able to identify a leak as small as 0.5 mm (0.020 inch). If a small leak is detected, a code P0442 will set.
