Remote Vehicle Start

Table of Contents -- November 2003	
Remote Vehicle Start	1
Unable to Program Replacement PCM	2
Passkey III+ Key Data Retrieval	2
Child Comfort Clip	3
Outer Tie Rod End Service Kit	3
Using "Getting to Know" Materials Effectively	4
Rotten Egg Exhaust Odor	4
Trim Panel Removal	4
Squeaking Seatback Clip	4
XUV Rear Wiper	5
Interior Light Override Feature	5
Seat Belt Extender	5
RCOHT Oxygen Sensor	6
Memory Seat Calibration	7
Oil Viscosity Usage	7
AC Vent Louver Repair	7
Poor HVAC Blower Vent Performance	7
Fix It Right the First Time	8
Know How Broadcasts for December	8

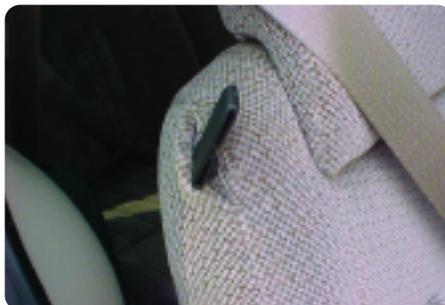
On Venture, Silhouette, and Montana vehicles, a child comfort clip is sewn into the rear seats, and is tucked into a fold on the outboard shoulder seam. This clip may get damaged or pull out.

A replacement service clip for 2002-03 vehicles is available from the Warranty Parts Center, according to Bulletin 03-09-50-001. It explains how to get the part and how to install it.

TIP: Install the replacement clip rather than replacing the seat back cover.

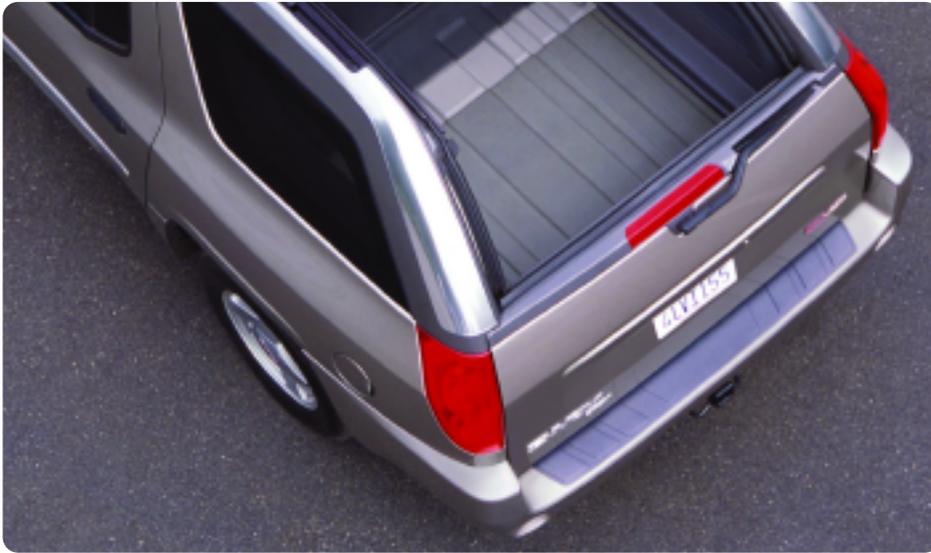
Wiper arm parked in applique pocket

The rear wiper system for this vehicle is designed to park the wiper arm in a depression, or pocket, in the end gate applique.
