Pontiac Vibe Tips

Chevrolet Aveo Tips

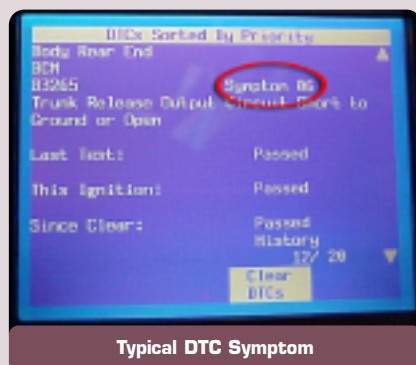
Typical DTC Symptom

Briefly, due to the way DTC numbers were issued in the past, the list of numbers available for DTCs used on GM vehicles worldwide was being rapidly depleted. So, when the GMLAN communication system was being developed, a method was found to include additional data in each DTC message. This permits more information about a circuit failure to be displayed on the scan tool without needing additional DTC numbers. The extra data is called the DTC Symptom.

TIP: A complete DTC Symptom Description is found in SI for each vehicle to which it applies. Follow this path:

IMPORTANT: When you're working on a vehicle that displays DTC symptoms, be aware that the DTC symptoms contain information that should be provided on repair orders and warranty claims, and should be reported when talking with Technical Assistance. Engineers consider the DTC symptoms as a part of the DTC and write them as part of the DTC, separated by a space.

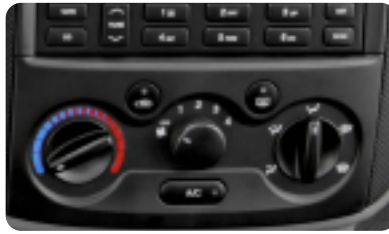
2005 Aveo A/C System

For 2004, the base-level Chevrolet Aveo was not available with A/C. For 2005, the base-level model can be upgraded with a dealer-installed manual A/C system. To expedite this installation, all base-level Aveos are equipped with factory-installed A/C prep equipment. The accompanying table shows the content differences between the 2004 and 2005 vehicles.

TIP: Only cars with RPO C59 can be upgraded using the dealer installed kit, p/n 96430552. Installation instructions are included in the kit.

TIP: A 2004 C46 Aveo cannot be upgraded to a 2005 C59 configuration. The A/C kit is not compatible with the 2004 C46 equipped Aveo.
