A Monthly Publication for GM Dealership Service Professionals

# **Revised Brake Bleeding Procedure**

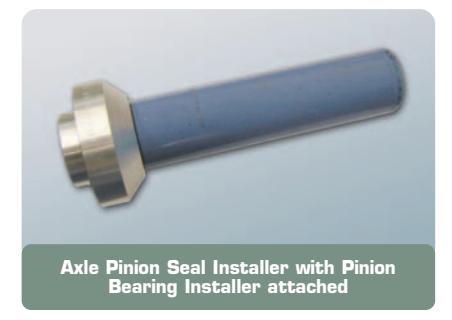
Recently, Kent-Moore has made a change to two axle pinion seal installers.

Tool J-24384, the 10.5-inch Axle Pinion Seal Installer and J-36366, the 8.25-inch Axle Pinion Seal Installer, were changed from molded plastic to machined aluminum. The tools were changed to improve quality and durability.

When using either of these new installers, the J-5590 Pinion Bearing Installer needs to be attached to install the seal.
