A Monthly Publication for GM Dealership Service Professionals

# Midtronics PSC 550 Battery Maintainer Now Essential

### **Techline News**

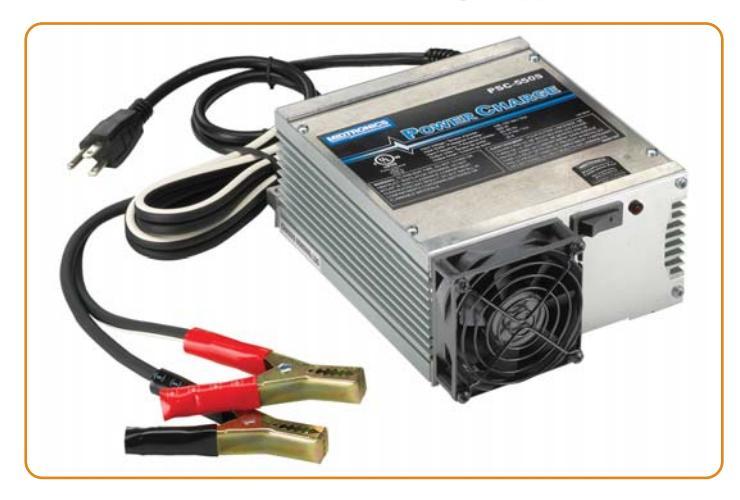
Successful programming requires a stable supply of battery voltage. If voltage falls too low during SPS events, programming may cease and ECU damage may occur.

Advanced technology vehicles such as the 2-Mode Hybrid require a sequential SPS event where as many as 6 discrete modules are programmed in one event taking 45 to 90 minutes. In these cases, even a fully charged battery is not sufficient to maintain system voltage during a sequential event.

For these reasons, it's recommended that an external power supply be used during all programming events. However, stable voltage is critical during programming. Any fluctuation, spiking or loss of voltage will interrupt programming, which could cause the controller to lock up. Two critical items are:

The PSC 550 Maintainer (also called the SPS Programming Support Tool EL-49642) meets these requirements. The main function of this tool is to act as a clean power supply during programming to avoid module failures.

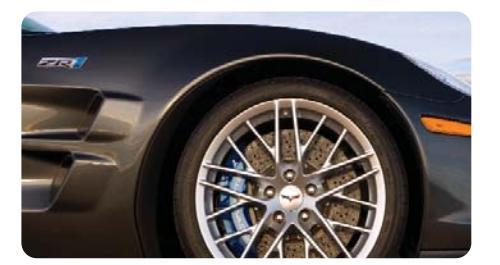
The ZR1 Corvette is equipped with ceramic brake rotors, which offer a number of benefits over cast iron rotors:

*IMPORTANT:* Disc brake rotor protectors MUST be installed before tire and wheel assembly removal to avoid ceramic brake rotor damage due to contact between the tire and wheel assembly and the rotor. If the ceramic brake rotor is damaged, replacement may be required.

To prevent damage to the ceramic rotor, install a foam rotor protector before removing any wheel. Protectors can be installed through the spokes of the wheel.

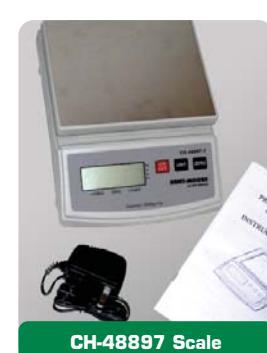
The rotors must be weighed before every pad replacement to confirm that the rotor mass is above the minimum (discard) weight embossed on the rotor. The rotor must be replaced if the mass is below the minimum weight.

Special tool CH-48897 is a scale that accurately measures the mass of the brake rotor to determine its suitability for re-use. Before each measure-

ment cycle, use the supplied calibrated weight to calibrate the scale.

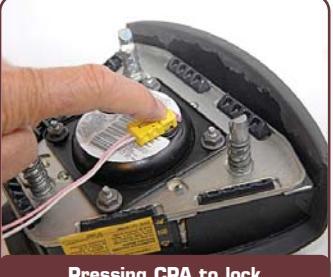
Pressing CPA to lock

There is a replacement CPA for the FCI connector used on some airbag inflators. It is available as p/n 54590003.
