A Monthly Publication for GM Dealership Service Professionals

Wheel and Tire Balancing

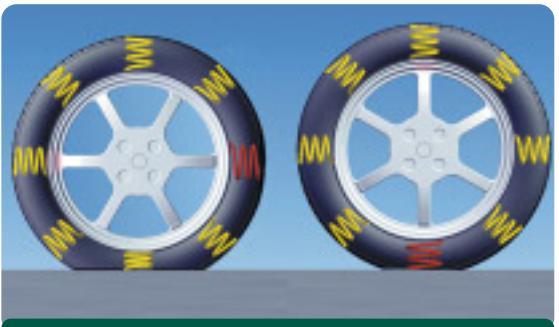
As you can see in the accompanying illustration, it's helpful to think of the tire's sidewall as a series of coil springs. If one of the "springs" is considerably stiffer than the others, the tire will bump each time that portion contacts the pavement. This will be perceived as a vibration.

Radial Force Variation compared with a spring

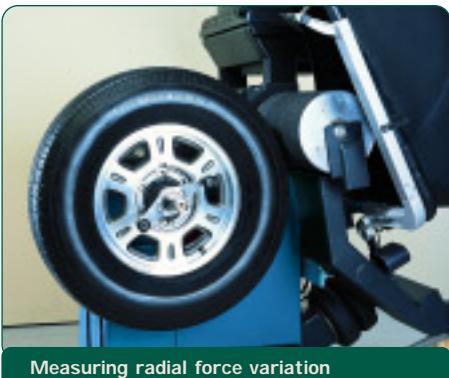
Inner and outer Dataset[®] arms equipped with sensors measure the wheel's runout.

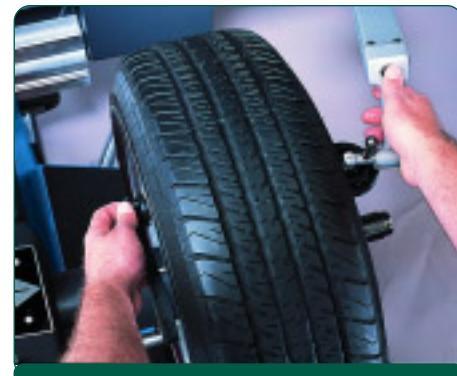
Positioning Dataset® sensors

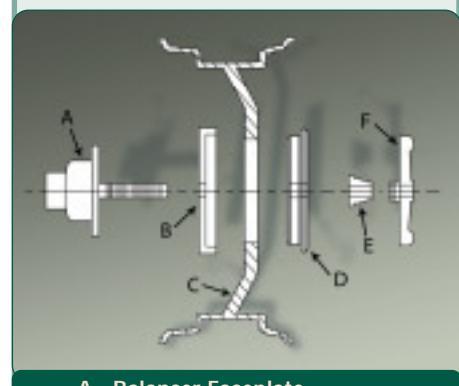
A - Balancer Faceplate B - Backing Plate C - Wheel D - Adapter E - Cone, Used as Spacer F - Nut

TIP: The adapter and backing plate used to align the hub of the wheel to the balancer are relatively new, and are available by calling 1.800.GMTOOLS (1.800.468.6657). Mount the wheel on the balancer using the parts shown in the illustration.

Rotate the wheel/tire assembly until the valve is at 12 o'clock. Loosen the nut. If the hub hole in the wheel does not fit the adapter snugly, the wheel will drop slightly and "hang" on the adapter, with the valve at 12 o'clock position. Then tighten the nut to secure the wheel to the balancer.
