A Monthly Publication for GM Dealership Service Professionals

2004 Secondary AIR Injection System

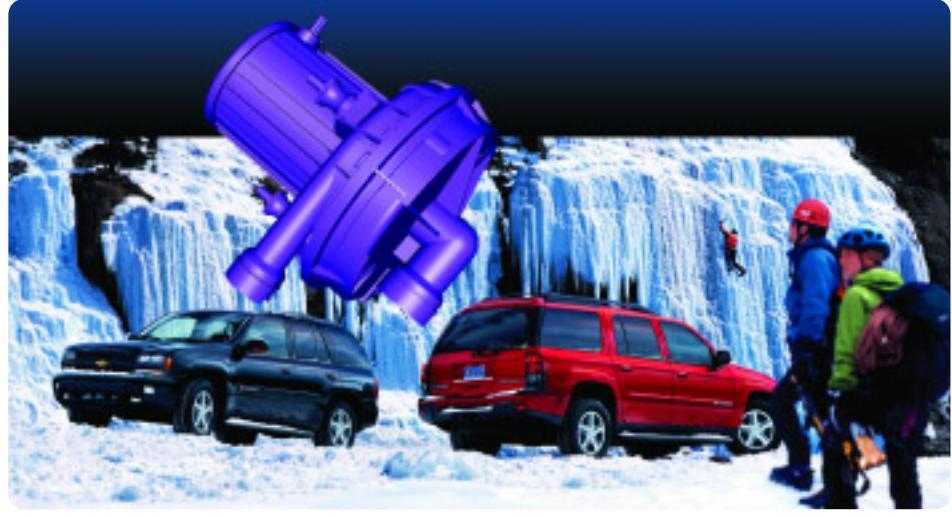
The Secondary AIR system used in the 2004 TrailBlazer, Envoy, Rainier and Bravada with the 4.2L in-line 6-cylinder engine incorporates a new AIR pump and an electronic AIR shut-off valve.

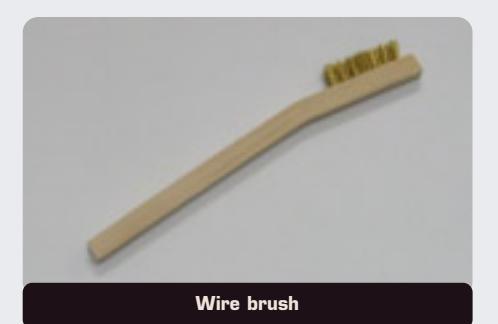
Under some circumstances, the nap may become crushed down, giving the appearance of being worn out. **TIP:** If the base material is visible, the material is worn, and this procedure is not a remedy.

Nap worn through to base material

If the base material is not visible, use a small wire brush to carefully raise the nap. Wire brushes similar to the one

shown are available at most hardware and home stores.

It is not necessary to use water or

cleaners to perform this procedure.

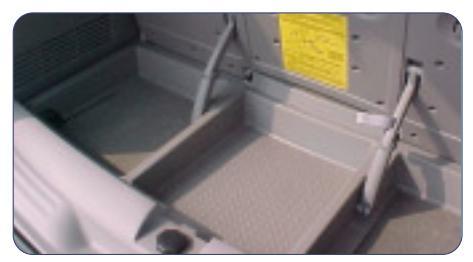
The hinge or support link in the rear storage compartment of 2002-03 Venture, Silhouette, and Montanta may break. Bulletin 03-08-110-001 addresses this condition.

The support link (also called hinge) is available as a separate replacement component.

TIP: Replace the support link, rather than the entire rear storage compartment.
