Removing Transseal Protective Film

Techline News

Service and Parts Operations

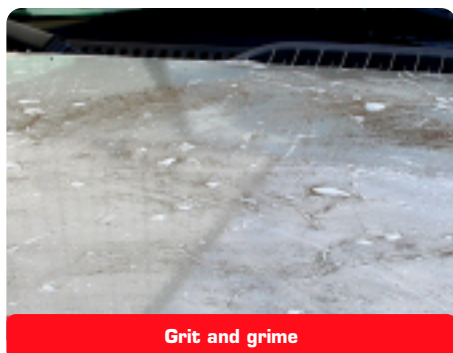
Grit and grime

The film must be thoroughly wetted with cool water. **Never use hot water.** Use a standard tap water from a garden hose, or a pressure washer within a range of 1000-2200 psi (6900-15000 kPa).

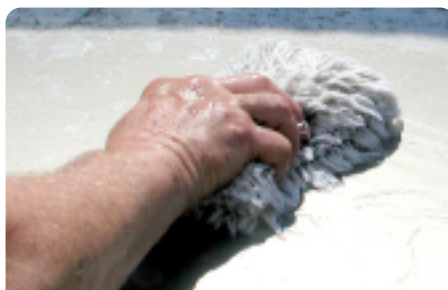
Removing dirt with mild soap

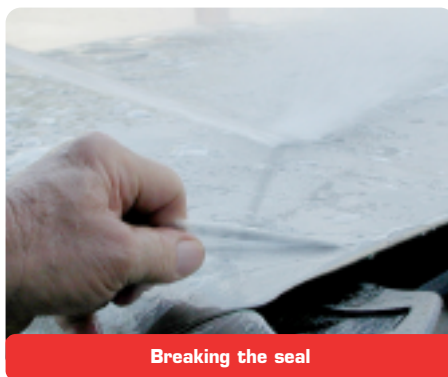
Breaking the seal

Perhaps the most effective method of removing the film is to peel a corner back to break the seal, allow water to penetrate under the film, then peel with one hand while directing the water with the other.

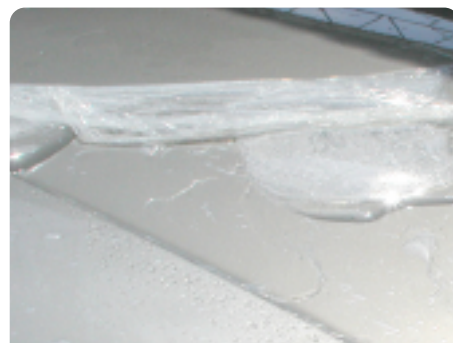
Allow water to penetrate under the film.
