New Pre-Delivery Inspection Form

Techline News

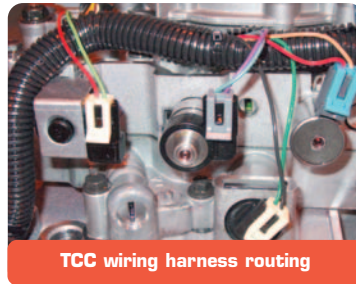
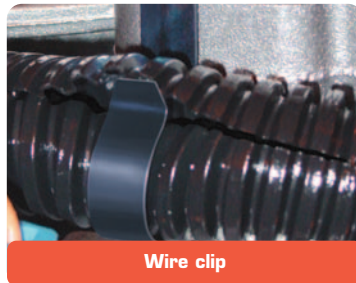
Perform the diagnosis as indicated by SI. If unable to control TCC with the Tech 2, suspect tan wire (ckt 418) shorted to ground. Follow appropriate SI instructions to access the transmission side cover to allow inspection of the internal wiring harness routing. PWM wiring should not be around the clip in the valve body. If the PWM wires are routed around the clip, remove and inspect for chafe or pinch. And correct the wire routing.
