A Monthly Publication for GM Dealership Service Professionals

Side Blind Zone Alert System

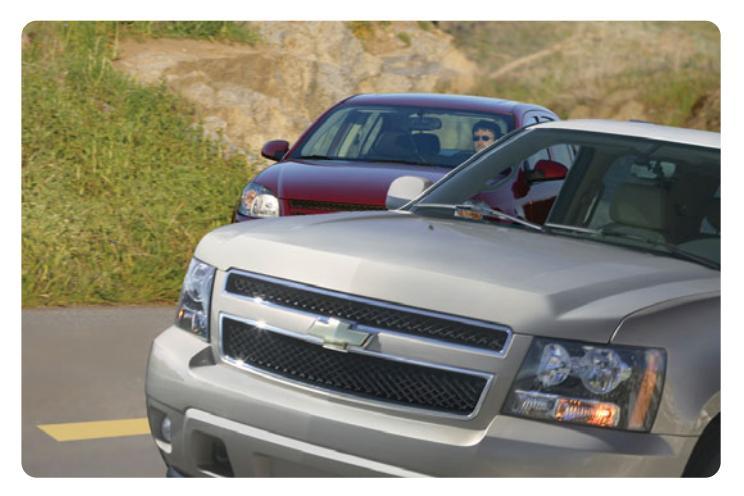
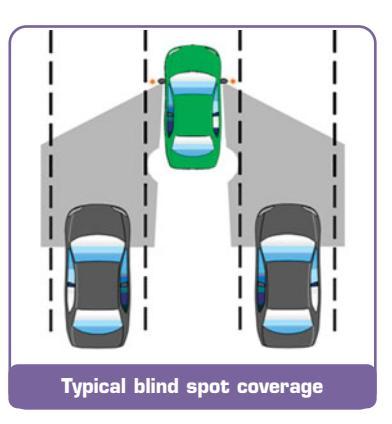
Lane-change accidents are caused by blind spots created by vehicle architecture, mirror resolution and a driver's physical capability to accurately assess a vehicle's presence, closing rate of speed and distance. Drivers changing lanes unaware of adjacent vehicles are the source of many near collisions every day. They are also the source of numerous damaged vehicles and injured people in North America each year.

By appropriately illuminating amber icons in the outside rear view mirrors, this supplementary system alerts drivers to the presence of other road users as they pass through the vehicle's left and right side blind spots. An icon will flash to heighten the alert when turn signals are active on that side of the vehicle.

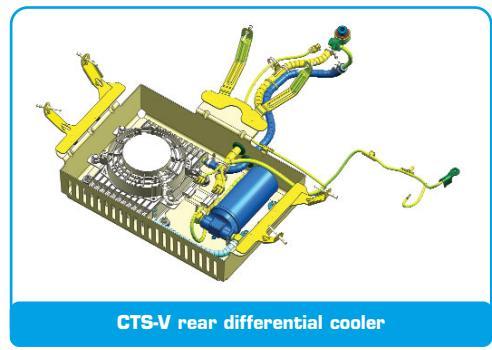
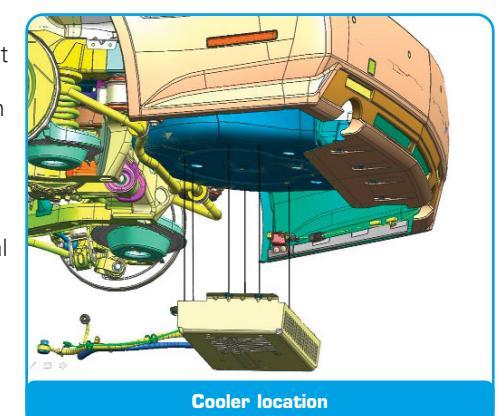
The system is designed to reduce the operating temperature of the rear differential fluid when the CTS-V is driven at extended high speed or in competitive driving. The CTS-V differential cooler includes a temper-

ature switch to operate the system when high rear differential fluid temperatures are met. The rear differential housing has provisions for the temperature switch. Installation time is less than 2 hours.

The differential lubricant pump and cooler assembly are located under the vehicle and are mounted to the rear storage compartment well. The cooler module assembly consists of a pump, a heat exchanger, an electric fan and assorted hoses/fittings. All components except the external lines, temperature switch and fittings are located in the Cooler Module.

Oil is pulled from the differential and pumped through a hose to the cooler/heat exchanger. The differential oil is cooled by dissipating heat as the 12

volt electric fan blows outside air over the heat exchanger. The cooled differential oil then returns to the differential.

TIP: The pump and electric fan can be turned on using the temperature switch bypass plug included with the kit.
