# TECHLink

September 2003  
Volume 5, No. 9

Monthly Publication for GM Dealership Service Professionals

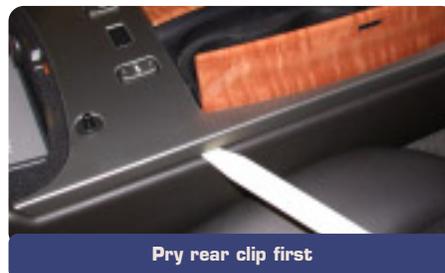
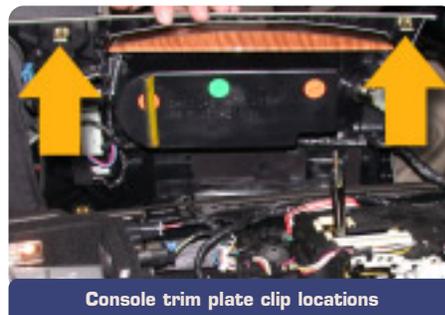
The console trim plate comes out first. Use a T-15 Torx bit to remove the shifter handle. Then insert the trim removal stick under the edge of the trim plate in the area of the rear clip and loosen the clip. Repeat this for each clip, then lift the trim plate off the console. Refer to the photo for the clip locations.

**TIP:** Use a plastic trim removal stick, to avoid damage to the trim or surrounding areas.

**TIP:** Be sure all clips are loosened before pulling on the trim plates, to avoid deforming the metal covering.

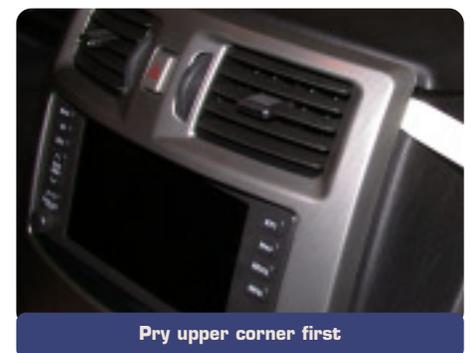
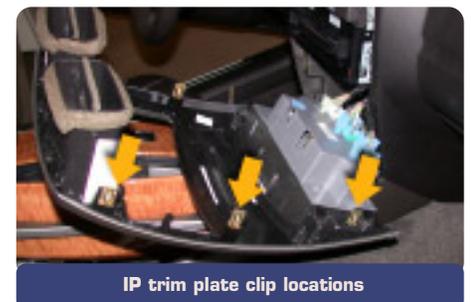
With the console trim removed, you can remove the IP trim plate. Insert the trim stick at the upper corner and loosen the top clips. Work down the sides and loosen the center and bottom clips. Then remove the trim plate. Refer to the photo for clip locations.
