Tire Tips

Techline News

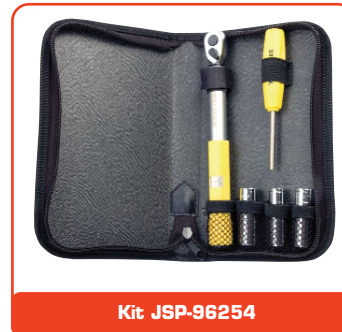
Kit JSP-96254

Valve stem torque wrench

When installing a TPM sensor, it is critical to use the correct installation torque for the valve stem. A stem or core can be damaged both by over- or under-torquing. Calibrated torque wrenches are available for both the stem nut and the valve core.

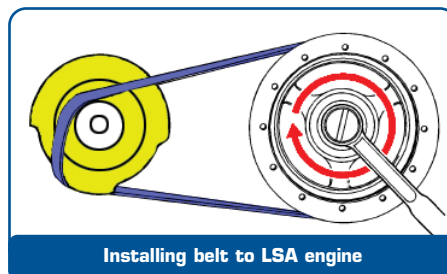
Installing belt to LSA engine

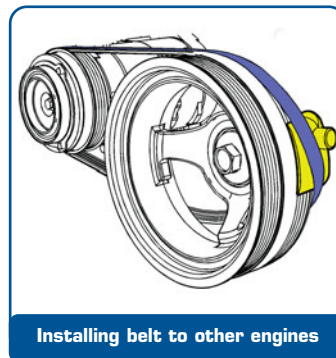
Installing belt to other engines

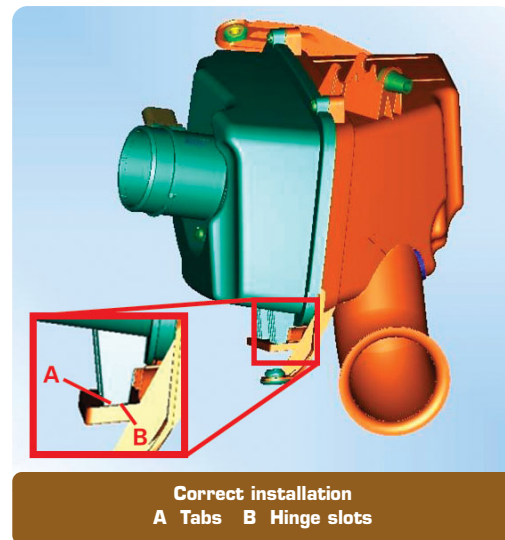
Correct installation
A Tabs B Hinge slots

TIP: If just replacing the filter element, the air cleaner (outlet side) cover does NOT need to be completely removed from the housing. The cover will pivot to allow for removal and installation of the filter element.
