Magnasteer power steering is now available on a wide range of cars from all five GM divisions.

Magnasteer is an electronic device added to conventional power rack and pinion steering to vary the amount of effort required to steer the car, dependent on vehicle speed. At low speeds, steering effort is lower, for ease in parking. As speed increases, steering effort is increased, for greater road feel. Additionally, on some models, evasive steering maneuvers also affect steering effort.

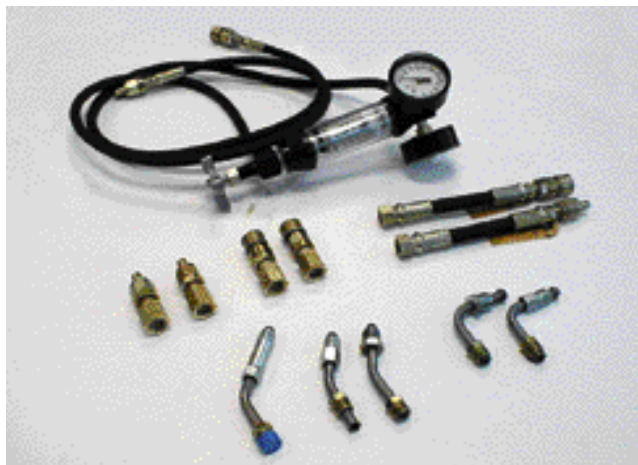
The major difference between the two analyzers is that the J-44721 is equipped with two pressure gauges instead of one, for accurate readings at both low and high pressures. Also, the J-44721 includes an adapter assortment that permits using the analyzer on all current GM cars and trucks.

In addition to the pressure gauges, the analyzer contains a flow meter to measure fluid flow under various conditions. And, a valve permits adding a variable restriction to the circuit as called for in the service manual procedures.

The analyzer is installed in the pressure line between the pump and the steering gear. If the system has been repaired, accurate diagnosis requires that the system be bled of air before beginning the test.

The hydraulic tests require you to observe pressure and flow readings under various operating conditions and engine speeds. Never close the control valve on the analyzer unless told to do so by the procedure, and never leave the valve completely shut for more than 5 seconds at a time.

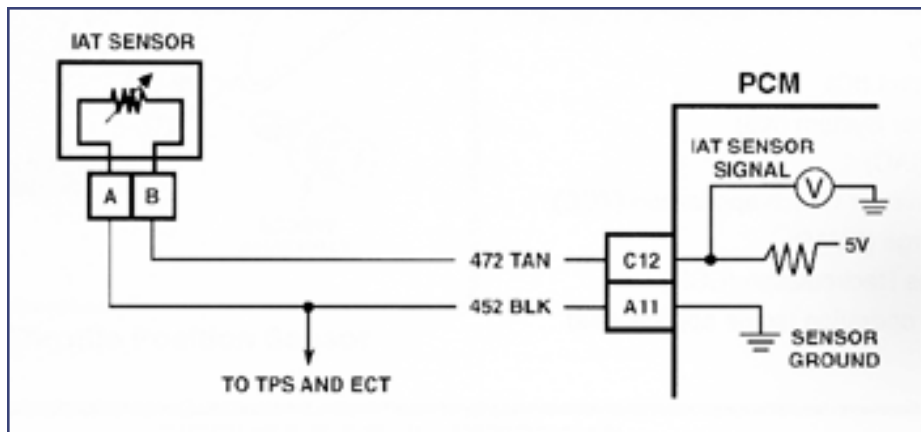
Circuit basics can be explained using the IAT diagram. The PCM supplies a 5-volt signal through a dropping resistor and out to the IAT on the tan wire. The IAT provides a ground path through the sensor and back to the PCM on the black wire. Note that this sensor ground is often shared by other components and can be influenced by a shorted condition within them.

When the IAT sensor is very cold (high resistance) it acts like a roadblock for the flow of electrons to ground. The IAT sensor signal in the PCM is high. As the IAT sensor heats up, the resistance drops, and more voltage is dropped across the sensor. The circuit is very simple.

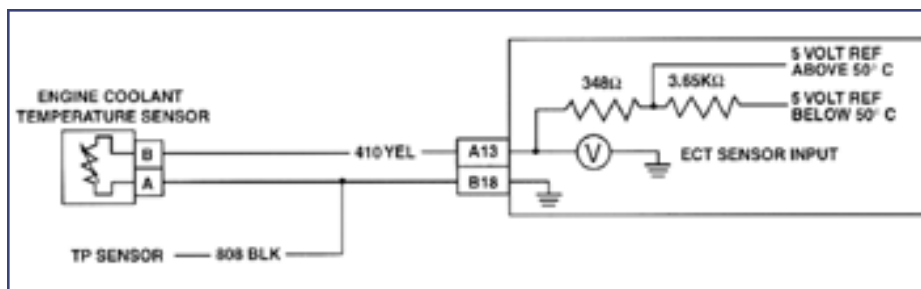
hours), scan data for ECT and IAT should be within ten degrees Fahrenheit.

If a malfunction in the circuit is suspected, observe the scan tool parameter with the sensor unplugged. The unplugged sensor will create very high (infinite) resistance and the scan tool should show a very cold temperature (approximately -40 degrees Fahrenheit). If this does not occur, check the sensor wire for open circuit voltage with a Fluke 87. It should be 5 volts. Less than 5 volts indicates a short to ground condition or a bad PCM.

The next quick circuit check involves a test lead outfitted with two appropriate male terminals. Use this test lead to jump the two sensor wires at the unplugged connector and observe the scan tool parameter. This low resistance connection should yield a very high temperature (260 degrees Fahrenheit or above). Failure of this test indicates ground circuit problems.
