## SI 2000 Hits Dealerships

## New Ignition Cassette Brings It All Together

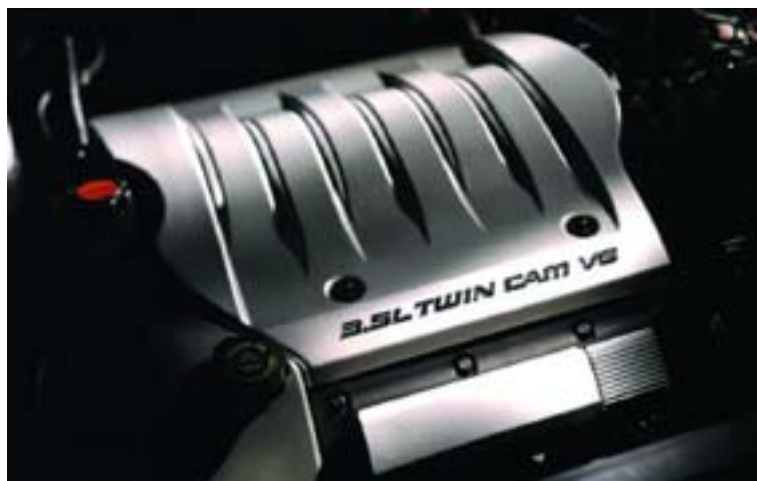
For each cylinder bank, all of the ignition coils and a coil driver module are incorporated into an assembly known as the ignition cassette. It's installed to the cylinder head cam cover with several bolts. Each ignition coil is connected directly to its corresponding spark plug by a secondary boot and spring, so there is no need for secondary cables.
