New-Style Battery to Appear in 2001 Corvette

New-Style Battery to Appear in 2001 Corvette . . .	1
The Three Cs	2
The Second Time Around	4
Understanding the Rear Parking Assist System . .	5
Setup Procedures for New Modules	6
TAC Tips	7
Disable Side Impact Air Bags Before Door Repairs	8
Bulletins	8

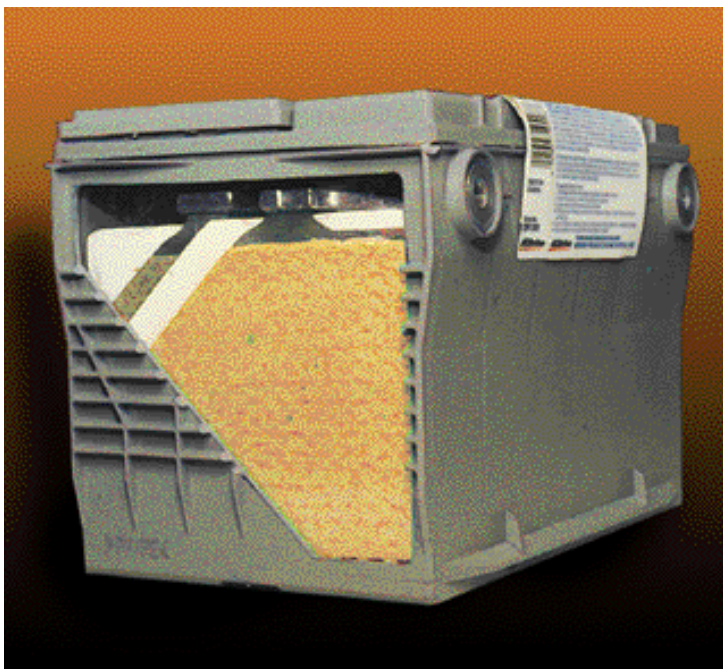
The lead plates (TAN) in the AGM battery are separated by fiberglass mats (WHITE).

When the AGM battery is manufactured, a lifetime supply of electrolyte is absorbed and held in contact with the lead plates by glass mat separators

The AGM battery's molded polypropylene case and cover are heat-sealed. A built-in one-way valve prevents loss of internal gases and prevents external elements from entering the battery and upsetting the chemical balance. If internal pressure exceeds 2

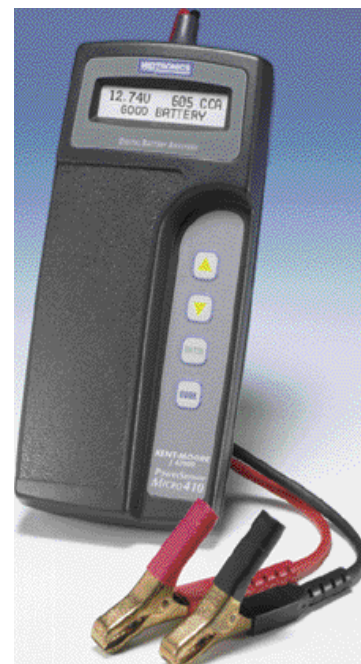
A corrected CCA must be used when testing the AGM battery with the J-42000 Conductance Tester.

When you have completed the test, locate the diagnostic code provided by the J-42000 readout and record it on the repair order for warranty purposes. Remember that a battery that fails an in-vehicle test must be retested out of the vehicle to confirm that the battery should be replaced. Record only the results of the out-of-vehicle test on the repair order.
