## Service Programming Things to Check When You Connect

### Contents

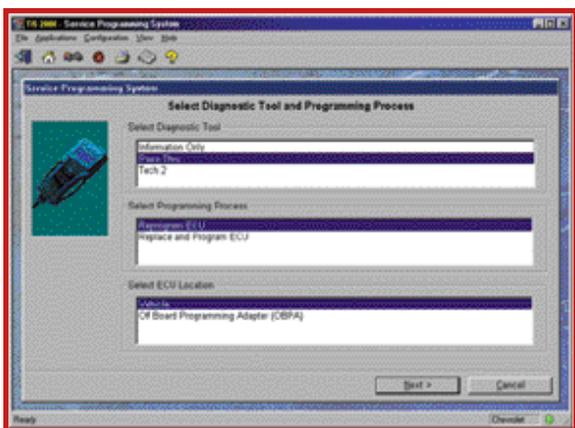
Service Programming can be performed using three different methods.

There are three Service Programming

System (SPS) programming methods. Remote SPS Programming, which we just described. Off-Board Programming, which is used when a control module must be programmed without having the vehicle present, requires using an Off-Board Programming Adapter (OBPA) to provide communication between the control module and the Tech 2. And the latest programming method is Pass-Thru Programming. Pass-Thru was introduced last year and allows the PC to be connected to the vehicle using the Tech 2 as a communications interface. With Pass-Thru, a new calibration file is downloaded straight to the vehicle control

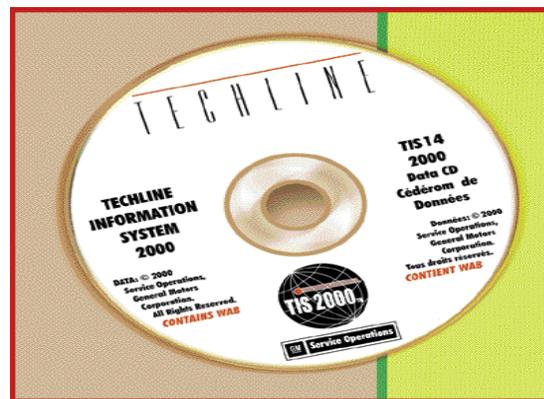
Update the Tech 2 and PC with the latest software before reprogramming.

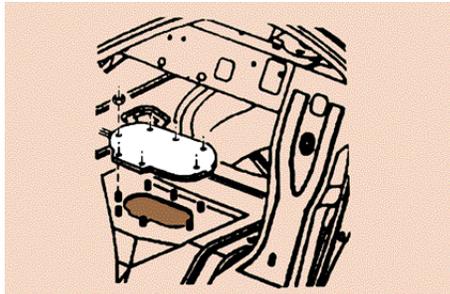
If you're looking for an easy way to access the fuel sender, take a look in the trunk. That's where you'll find the fuel sender assembly access panel on 1997-2001 Buick Regal and Century and

Pontiac Grand Prix models, 1998-2001 Oldsmobile Intrigue models and 2000-01 Chevrolet Impala and Monte Carlo models.

The fuel sender assembly access panel on these vehicles is underneath the rear compartment trim. It may be necessary to remove the spare tire cover and rear compartment trim. The fuel sender access panel can be found near the front of the trunk. It can be reached either through the trunk, or on vehicles with folding rear seats, through the rear seat area. Check the appropriate service manual for complete repair information.

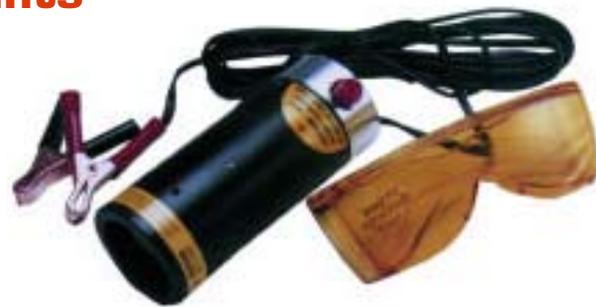
A new A/C charge label that indicates that the A/C

system "contains refrigerant dye" will be placed on vehicles receiving the leak dye. Some vehicles, however, will receive the leak dye before the label is available.
