GM Oil Life System Revisited

Techline News

GM Oil Life System Revisited	1
How to Search on the TechLink Website	1
Starter Cranks After Key is Released	2
Power Door Lock and Window Switch	2
Reorganization Changes Coming to SI	2
Know-How Broadcasts for June	2
Oil Life System Reset Procedures -- Cars	3
Simplified Maintenance Schedules Coming	4
Tracker Windshield Replacement	5
A New Kind of Oxygen Sensor	6
Bulletins	8

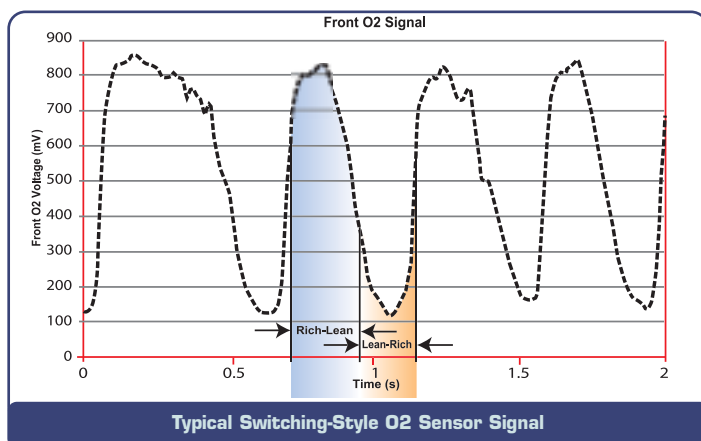
Most switching-style oxygen sensors operate within a range of 0 to 1000 millivolts, and as a result will not provide an accurate reading when the air-fuel ratio exceeds approximately 14.6:1 when rich or 14.8:1 when lean.

The WRAF sensor can provide an accurate signal when the air-fuel ratio is as lean as 16:1 or as rich as 11:1, allowing the engine controller to continuously adjust fuel trim throughout this wide range of air-fuel ratios. So, a second advantage of the WRAF sensor is its ability to provide an accurate signal while operating in an air-fuel ratio, or lambda state, other than stoichiometric.

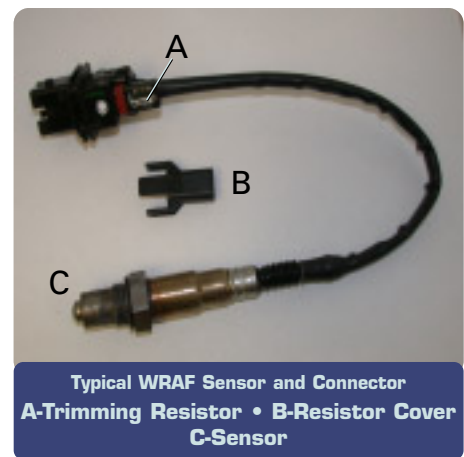
WRAF Wiring and Circuits

The WRAF sensor has six wires (circuits), divided among three functions.

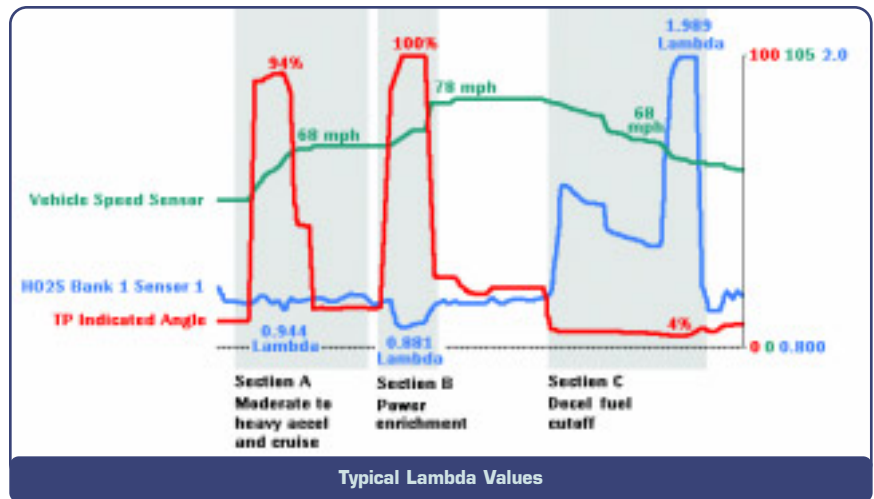
Typical WRAF Sensor Lambda Values

Acceleration and Cruise – The lambda value stays fairly flat, close to 1.000, during the moderate to heavy acceleration and

during cruise (Section A). This is because the sensor and the engine controller are in their own closed-loop operation and the lambda value only "drifts" above or below 1.000 as the engine controller makes its fuel trim adjustments. This closed-loop operation between the engine controller and the WRAF sensor is an instantaneous reaction to voltage deviations between the reference voltage circuit and low reference circuit and the resulting oxygen ion exchange via the pumping circuits.

Power Enrichment – The lambda value moves lower when power enrichment is active (Section B).

Extreme lambda values are a result of the limits of the controller hardware and software. When a vehicle enters a fuel cut-off state during deceleration, the lambda value may move to a very high number (infinity) because the controller software and hardware are operating the pumping circuits at their maximum correction state to offset the extremely lean air-fuel ratio that is occurring. The controller software will not display infinity but will instead display a large number. Depending on the controller manufacturer, these maximum limits may be as low as 0.750 during a very rich condition, or as high as 3.999 during a very lean condition.
