A monthly publication for GM Dealership Service Professionals

Magnetic Ride Control

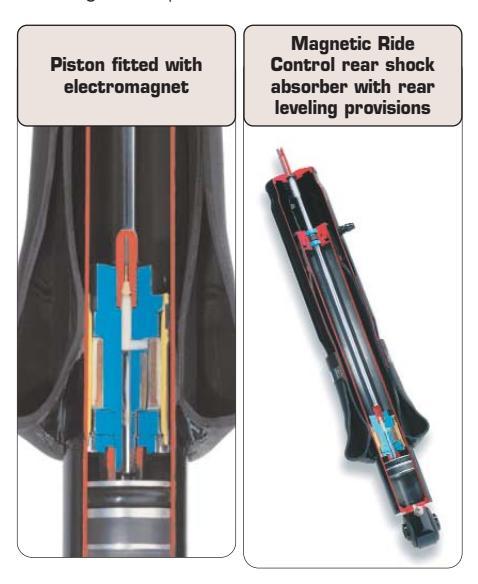
Without a magnetic field, the fluid is not magnetized and the iron particles are scattered randomly.

But when the magnetic field is turned on, the metal particles align into fibrous structures, changing the fluid rheology. This essentially instantaneous thinning or thickening of the fluid regulates the damping properties of the struts.

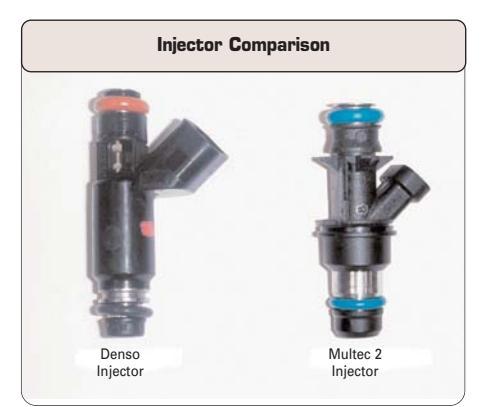
The L59 uses Denso injectors that are not interchangeable with the Multec 2 injectors used in the other Gen III applications. The internal parts of this injector, as well as its O-rings, are able to withstand the lower lubricity E85 fuel. If you replace the O-rings, be sure they are specific to this injector. Also notice that the Denso injector is longer than the Multec 2.

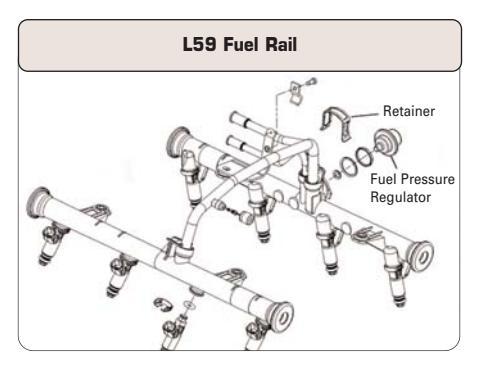
The fuel pressure regulator is also specific to the E85 fuel rail. It is larger in

diameter than those used in the other Gen III engine applications and uses a special diaphragm that is compatible with E85 fuels. The fuel pressure is different for this application – 334 to 375 kPa (48 to 54 psi).

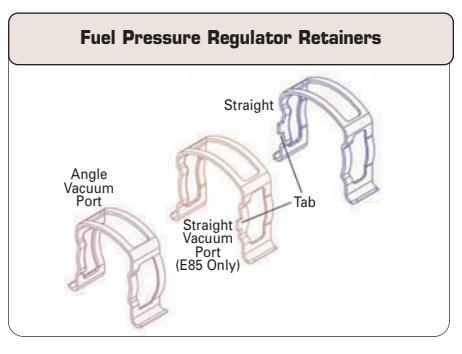
Three different fuel pressure regulators are used this year. Each one is held in place on the fuel rail by a unique retainer. The retainer diameter and window dimensions are different for each. Use the correct retainer to ensure adequate retention of the fuel pressure regulator. Note the ID tabs on the sides of two of the retainers.

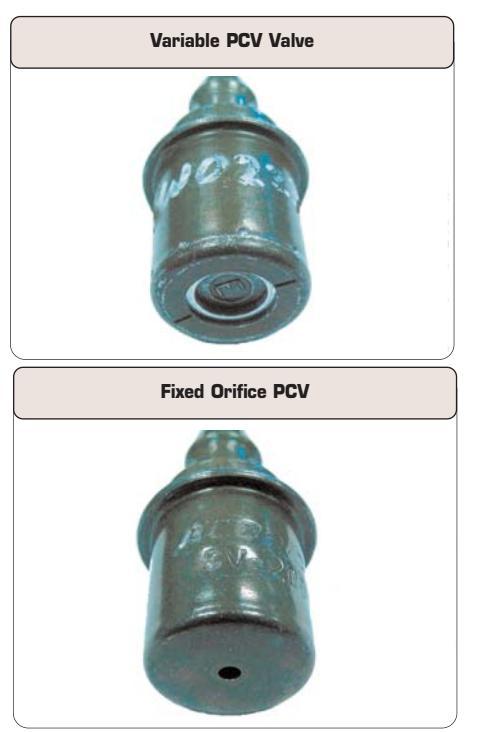
For 2002, there will be early and late model intake air fuel modules (IAFM), consisting of the throttle body, fuel rail and injectors, and intake manifold. The early IAFMs will be the same as 2001. Later manifolds have several design changes. The late throttle body has an increase in shipping air due to a change in the PCV system. The PCV valve will be changed from a variable valve to a fixed orifice.

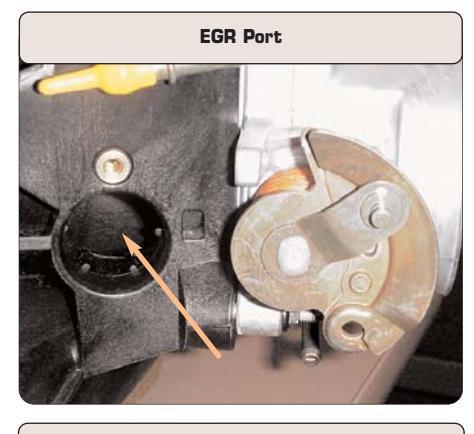
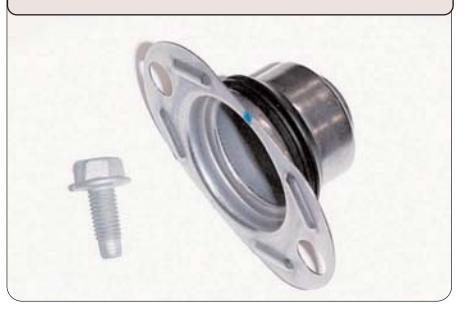
EGR Plug

Also the late production IAFMs on engines that do not require EGR will have a cast-over EGR port. All service replacement manifolds for 2002 will have an open EGR port. If the manifold you are replacing does not have EGR, you must install the supplied plug and screw, following the instructions in the parts package.
