A Monthly Publication for GM Dealership Service Professionals

Techline News

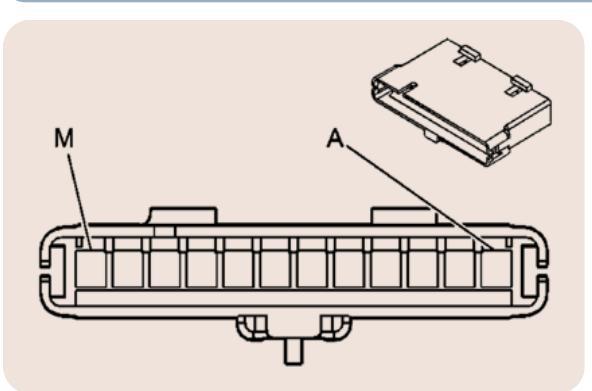
STAR Connector

The Class 2 data bus is generally wired in one of two ways: star or loop (see TechLink, June 2000). On vehicles with the star setup, all of the Class 2 lines come together at a star connector, with all lines joined by a removable comb. You can remove the comb from the connector and jump between the DLC terminal and the terminal for the

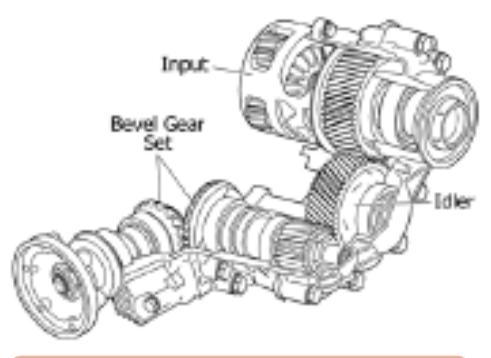
Transfer Case Geartrain

The Versatrak system begins with a power take-off unit (PTU) mated to the frontmounted 4T65-E automatic transaxle.

Power is transferred to the rear axle by an aluminum propeller shaft which leads to a torque tube assembly, mated to the rear differential. Inside the rear module, twin Geromatic units react to any difference in the rotational speed of the front and rear wheels. As long as no speed difference exists, all power is directed to the front wheels. If one of the front wheels begins to slip, the rear-mount-ed Geromatic gerotor pumps pressurize fluid to engage multi-plate clutches that redirect torque to one or both rear wheels.

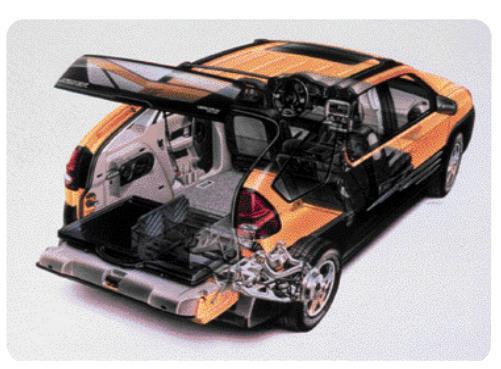
Versatrak fits under the rear load floor

The all-wheel drive system engagement is so smooth and progressive that it's nearly transparent to the driver and passengers. And, the Versatrak system is so compact that it fits under Aztek's flat rear load floor.

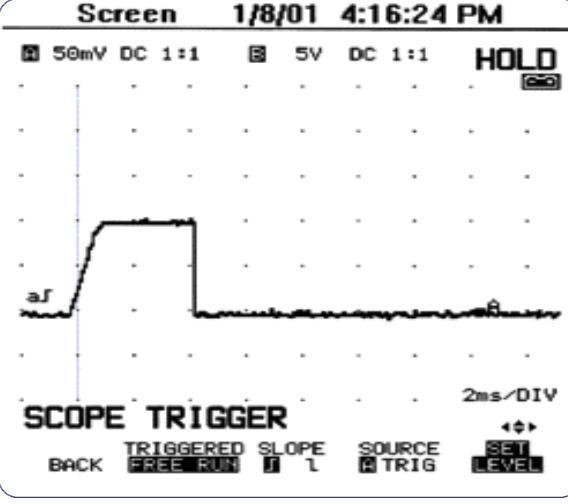
Current Trace of Saturated Switch Injector

The high tech way to test fuel injector circuitry integrity is with an oscilloscope and inductive current clamp. Simply check the current for each injector, one at a time, by installing the current clamp over a wire anywhere in the circuit. Look for high resistance to be indicated by low current when compared to the other injectors. This high tech method can not find where the fault is. Voltage drop testing is still necessary to do that. This will, however, quickly tell

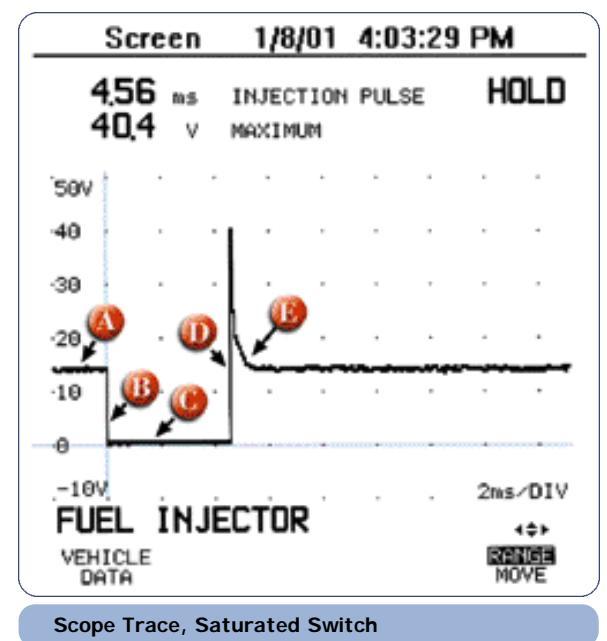
Saturated Switch Injector Patterns

Oscilloscope patterns of fuel injectors are typically obtained on the negative or PCM side of the circuit. Usually the circuit is carefully back-probed at the injector connector. Your scope negative lead should always be on battery ground, to identify ground circuit problems.

Remembering this, let's explore the trace diagram in the accompanying illustration. Area A in the diagram indicates battery voltage. The injector is off, so the circuit is open. Any point in this circuit should be at or very near charging system voltage. If it is not, recheck your fuel injector power feed.

Area B is the point at which the PCM completes the circuit to ground, turning on the fuel injector. The line should be clean and straight. A line distortion indicates a weak driver in the PCM.

Area C in its entire length indicates the "on-time" of the fuel injector. This should be very close to ground reference. If it is high, recheck your ground circuits to the PCM. If it ramps, a bad PCM driver may be suspected.

Area D is known as the "inductive kick" of the fuel injector. This is generated by the magnetic field collapsing in the fuel injector as it is turned off. The voltage achieved in this kick is in direct proportion to the health of the winding in the fuel injector. A strong injector has a high inductive kick. Typically, saturated switch injectors exceed 35 volts.

Area E is the descent ramp of the inductive kick. It is not uncommon to see a distortion at this location caused by the injector pintle passing back through the

winding. Commonly called a "pintle hump", this phenomenon is normal for some injectors.

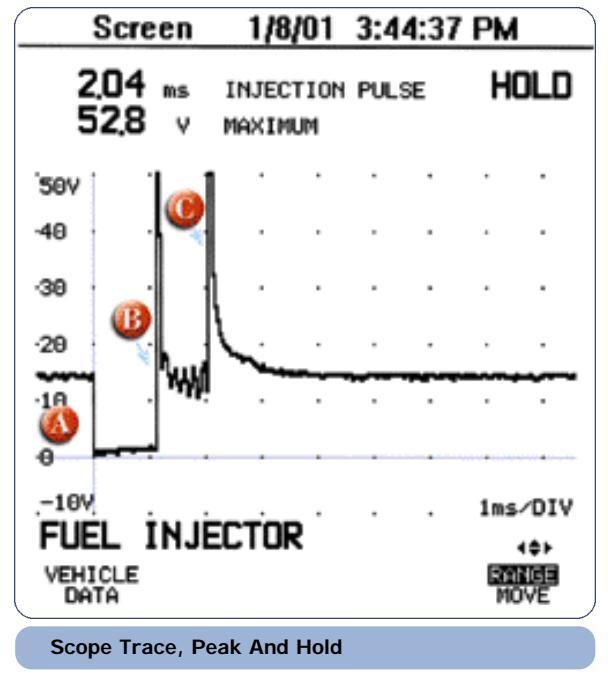
Peak and Hold Injector Patterns

Now for the peak and hold fuel injector drivers commonly found on TBI models. Remember, peak and hold injectors as discussed last month have a low resistance (1-2 ohms) in comparison with saturated switch injectors (12-16 ohms). So, they require more current to operate.

If you do a quick Ohm's Law calculation, you find that a 2 ohm injector in a 14 volt system will require 7 amps. We do not have any computer drivers that can do that for very long, however. The computer strategy is to turn on the injector, and hold it on at a lower current level by going into current limiting.

The first inductive kick at area B is a result of the PCM

entering current limiting. The second at area 6 is when the injector is shut off. The area between A and B is the "peak" time, which does not change with the on-time of the injector. Some ramping here on a peak-and-hold injector is considered normal.

Between B and C is the "hold" time

that changes with injector on-time. The entire pulse width, therefore, is between A and C. Inductive kicks on TBI injectors are typically lower due to less injector coil saturation.

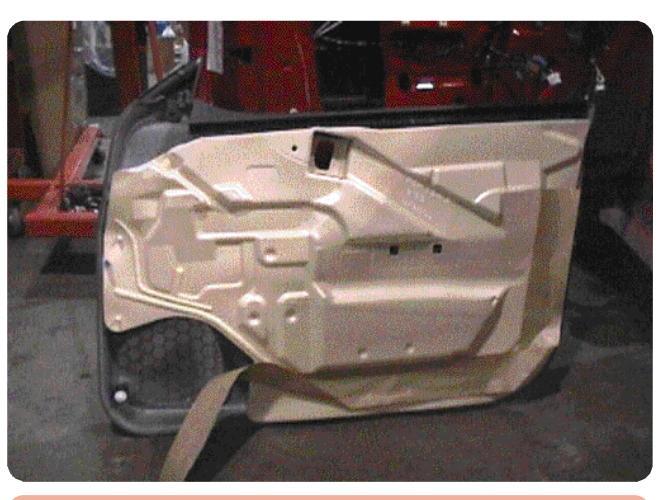
To access the window glass, window regulator, latch mechanisms, and other internal components, you must temporarily disconnect the water deflector. Carefully peel the top half of the deflector from the door, down to the crease in the acoustic mat. Use a plastic trim stick as necessary to disengage the adhesive.

Water Deflector with Backing Pulled Away to Expose Adhesive

If the upper portion of the water deflector is damaged, you may repair it by installing duct tape to the deflector, under the acoustic mat. But, if the lower portion of the water deflector becomes damaged, a new one must be installed. Locate the pre-punched holes in the replacement deflector onto the door trim Trim Panel Retainers. Pull the protective backing from the adhesive, and install
